ASBESTOS INSPECTION REPORT
1079/ 1081, 1253 & 1371 Airport Drive, 3 & 4 Delaware
Street, 53 North Henry Court, and 11 & 49 South Henry
Court
South Burlington, VT 05403
AIP 88

April 30, 2015

Stantec, Inc.
55 Green Mountain Drive
South Burlington, VT 05403

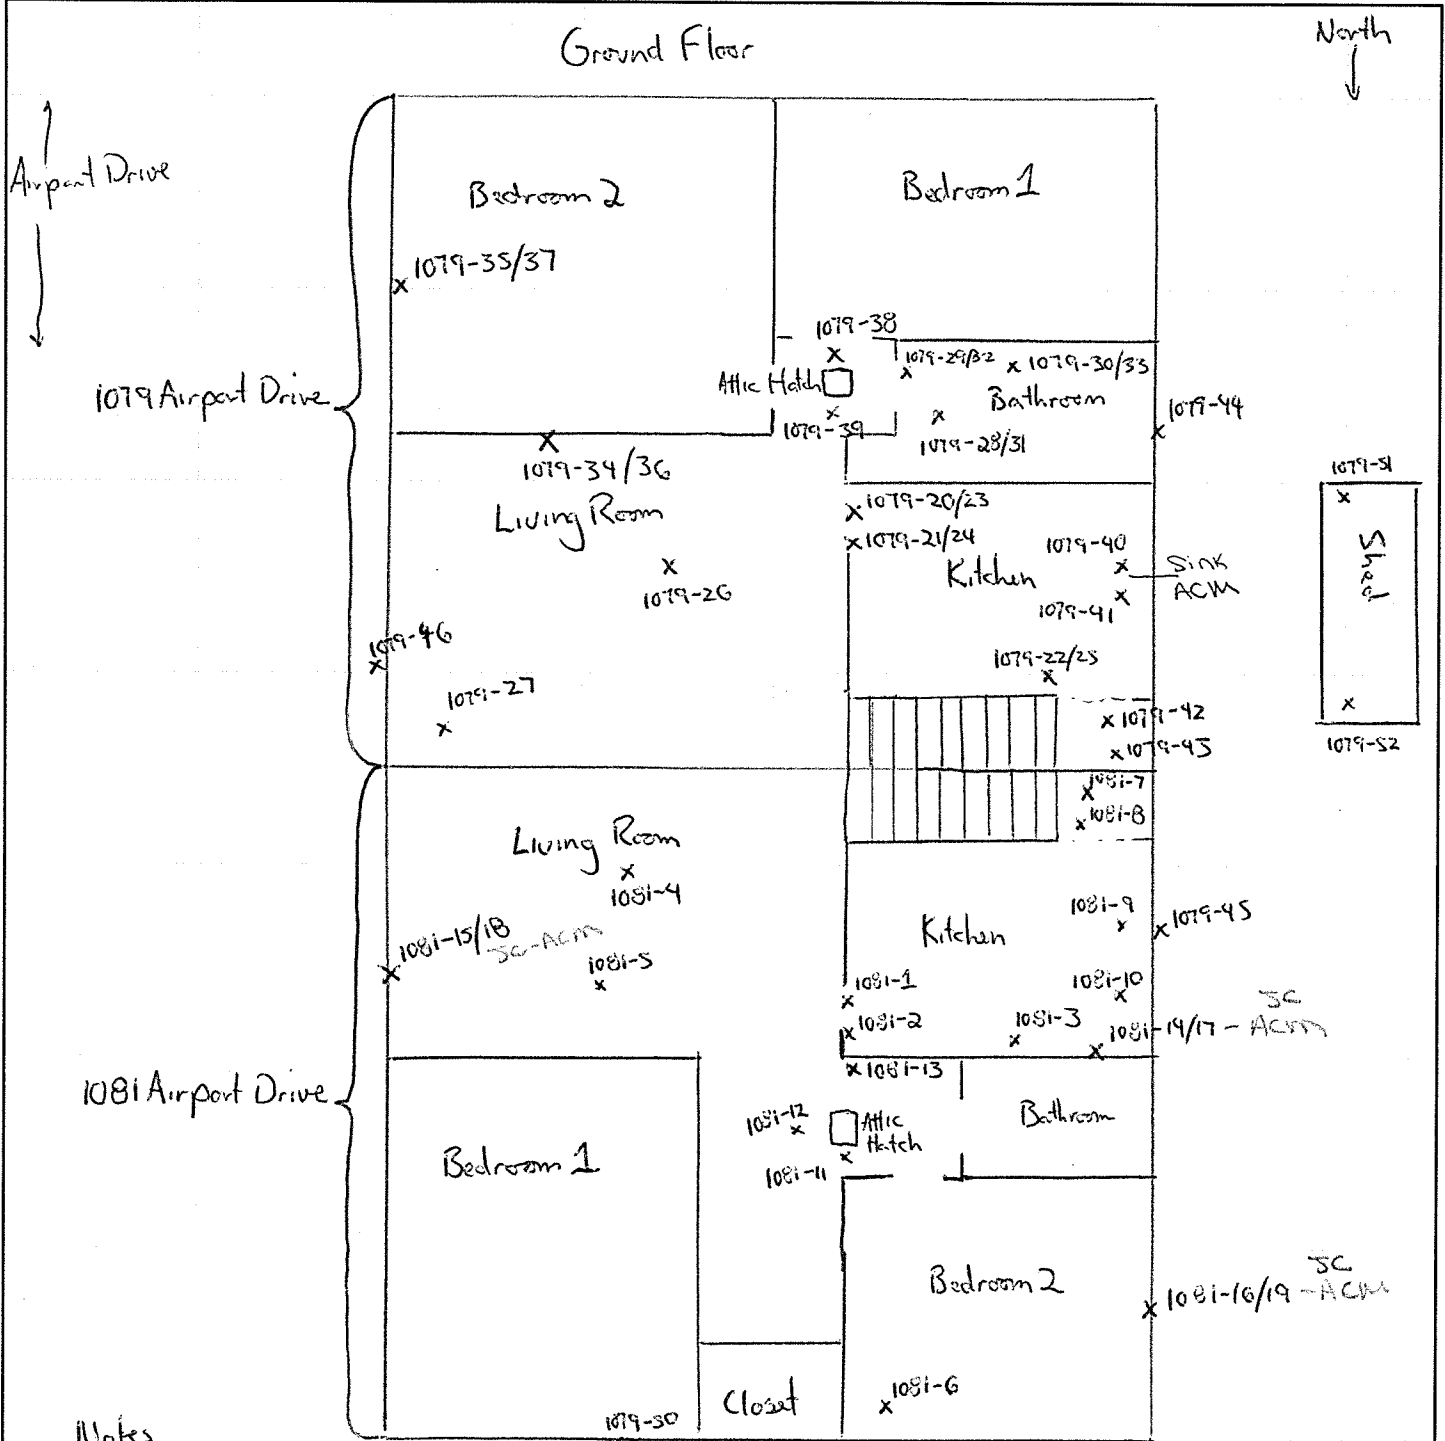
1079+1081 Airport Drive

- (1) x = sample location
- (2) 1081-1 = sample id
- (3) Vermiculite identified in attic space, assumed ACM
- (4) 1,2,3 Sample approx. locations
- (5) Representative drawings

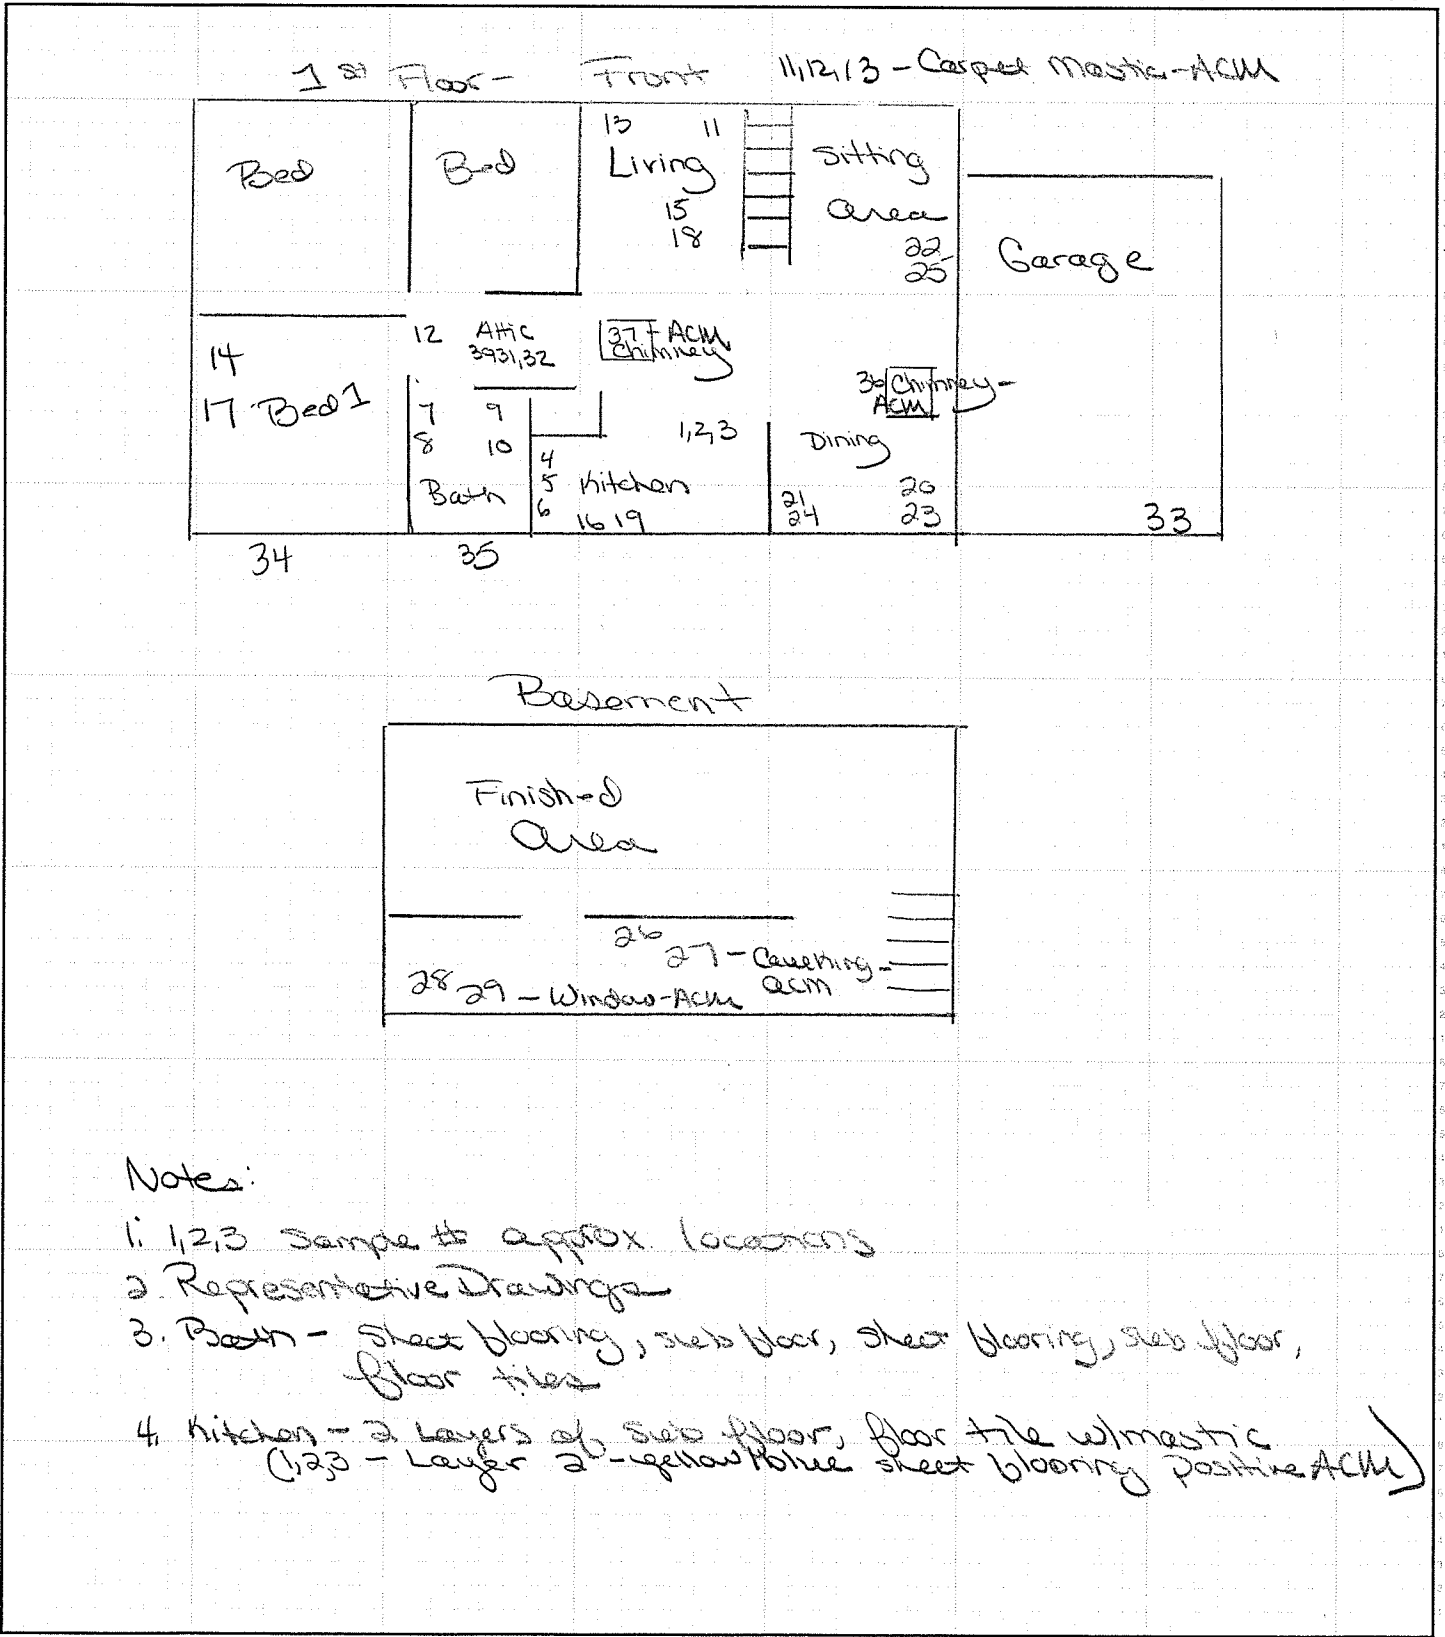
JOB 4 Delaware Street - 503/50367
 SHEET NO. 1 OF 1
 CALCULATED BY AK DATE 4/2/15
 CHECKED BY _____ DATE _____
 SCALE NTS

1. 1, 2, 3 sample to approx. locations
2. Representative Drawings
3. Bath - sheet flooring, sub floor, sheet flooring, sub floor, floor tiles
4. Kitchen - 2 layers of sub floor, floor tile w/mastic (1, 2, 3 - Layer 2 - yellow/blue sheet flooring positive ACM)
