**ASBESTOS INSPECTION REPORT**  
**1085, 1181 Airport Drive, 104 Airport Parkway, 1**  
**Elizabeth Street, 3, 7 Maryland Street, 24, 54 North Henry**  
**Court, 87 Pump Lane, 441, 448, 449, 451 White Street**  
**South Burlington, VT 05403**  
**AIP 92**

**April 29, 2015**

**Stantec, Inc.**  
**55 Green Mountain Drive**  
**South Burlington, VT 05403**

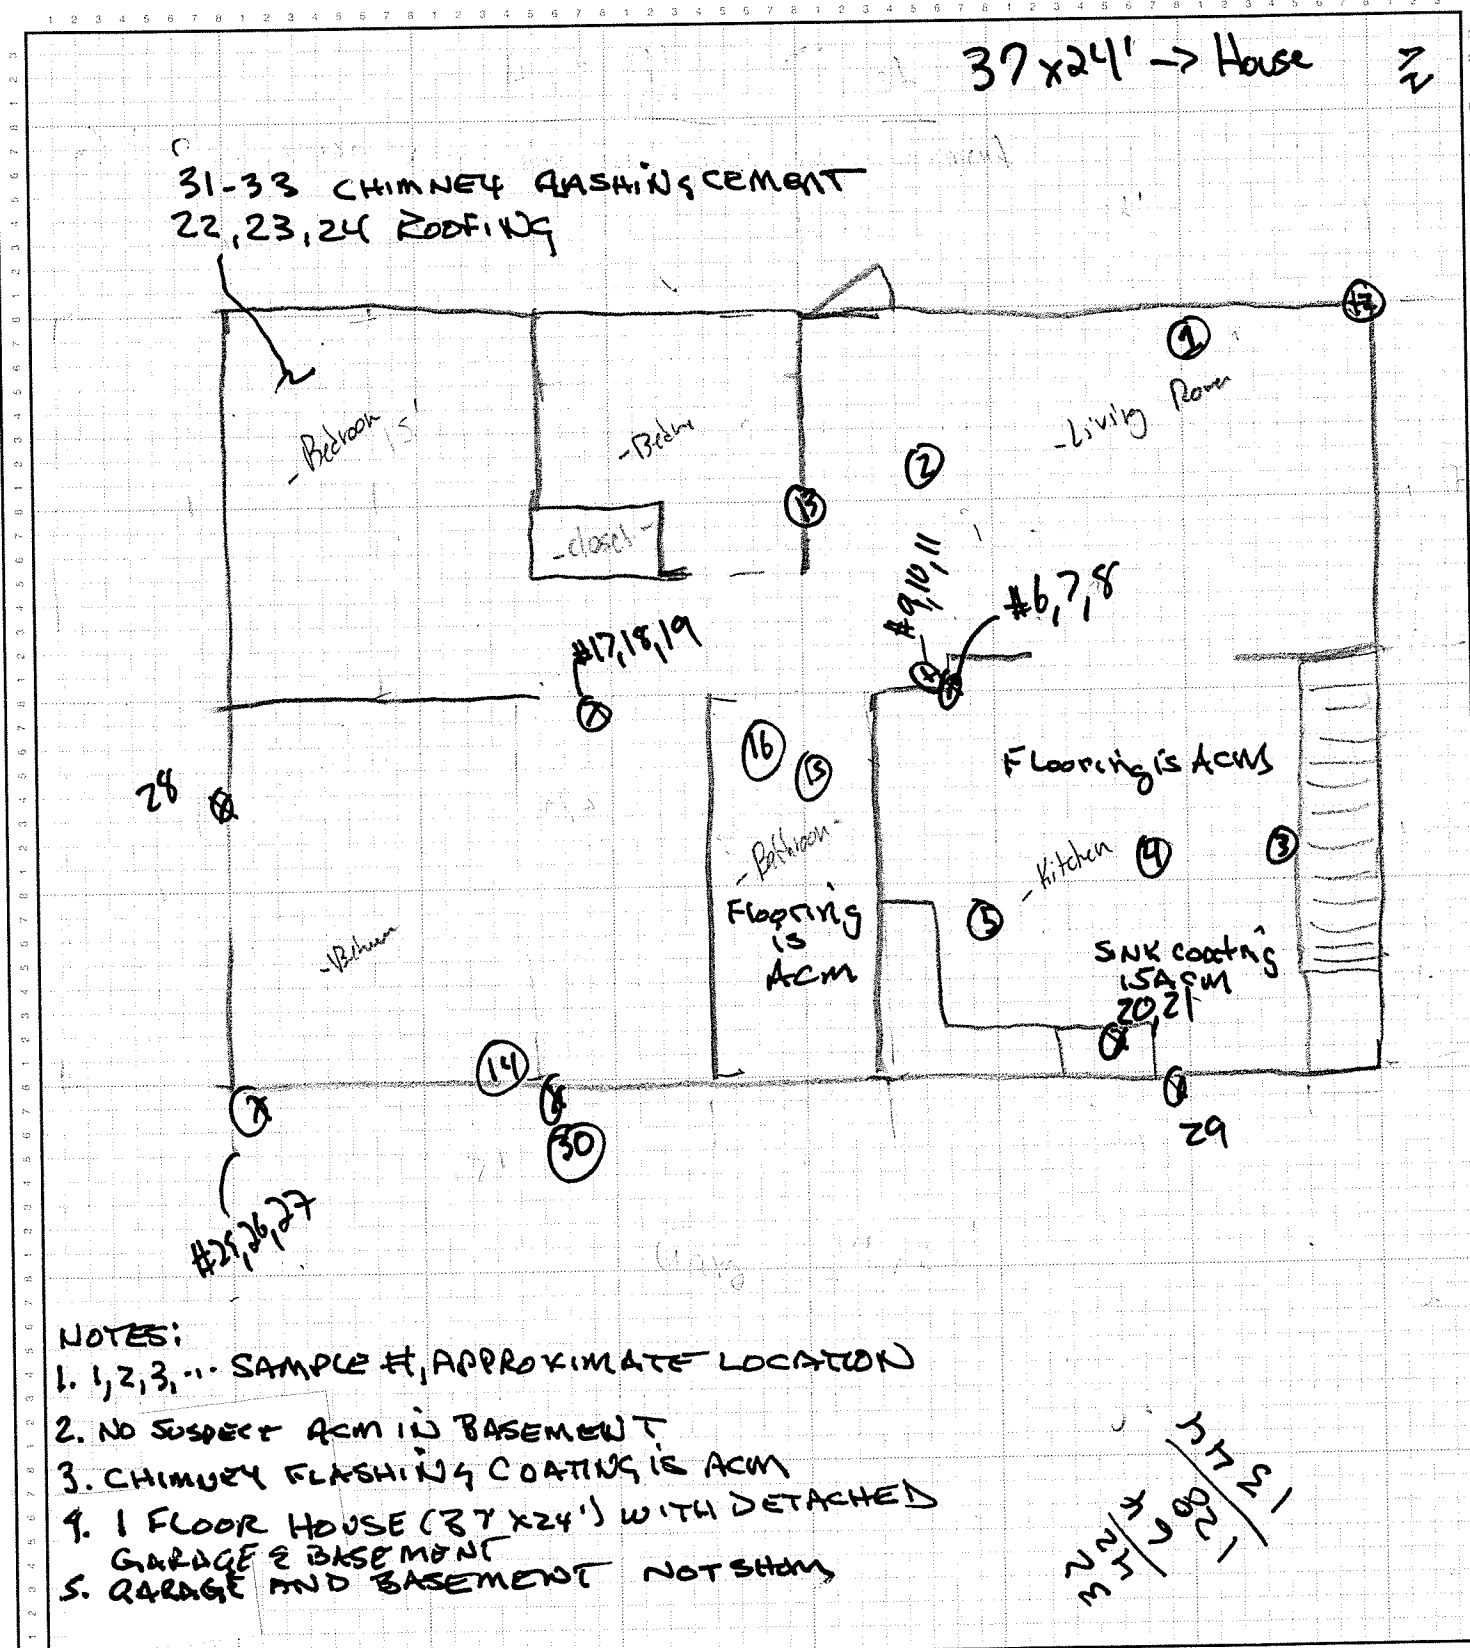
JOB 449 White Street 503150368  
 SHEET NO. 1 OF 1  
 CALCULATED BY PS DATE 4.24-15  
 CHECKED BY \_\_\_\_\_ DATE \_\_\_\_\_  
 SCALE NTS

- NOTES:
1. 1, 2, 3, ... SAMPLE #, APPROXIMATE LOCATION
  2. NO SUSPECT ACM IN BASEMENT
  3. CHIMNEY FLASHING COATING IS ACM
  4. 1 FLOOR HOUSE (37 X 24') WITH DETACHED GARAGE & BASEMENT
  5. GARAGE AND BASEMENT NOT SHOWN

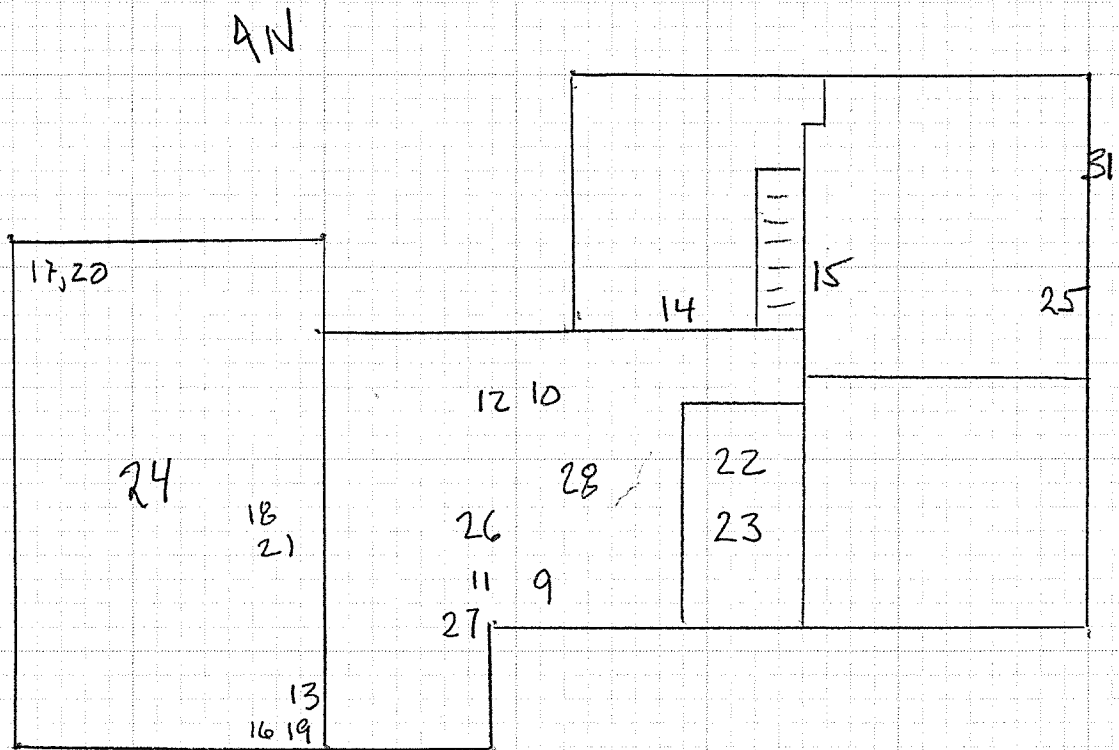
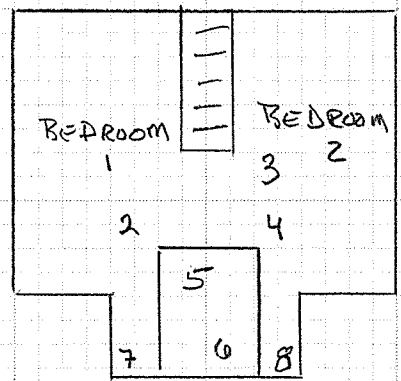
JOB 451 White Street 503150368  
 SHEET NO. 1 OF 1  
 CALCULATED BY PS DATE 4-24-15  
 CHECKED BY \_\_\_\_\_ DATE \_\_\_\_\_  
 SCALE NTS

- NOTES:
- 1) 1, 2, 3, ... SAMPLE #, APPROXIMATE LOCATION
  - 2) DRAWING REPRESENTATIVE - DOES NOT SHOW ALL FEATURES
  - 3) NO SUSPECT MATERIALS IN BASEMENT
  - 4) SAMPLES 32, 33, 34 ARE ROOFING
  - 5) VERMICULITE INSULATION IN ATTIC IS ACM
  - 6) NO ACM IN OR SECOND FLOOR, OUTSIDE

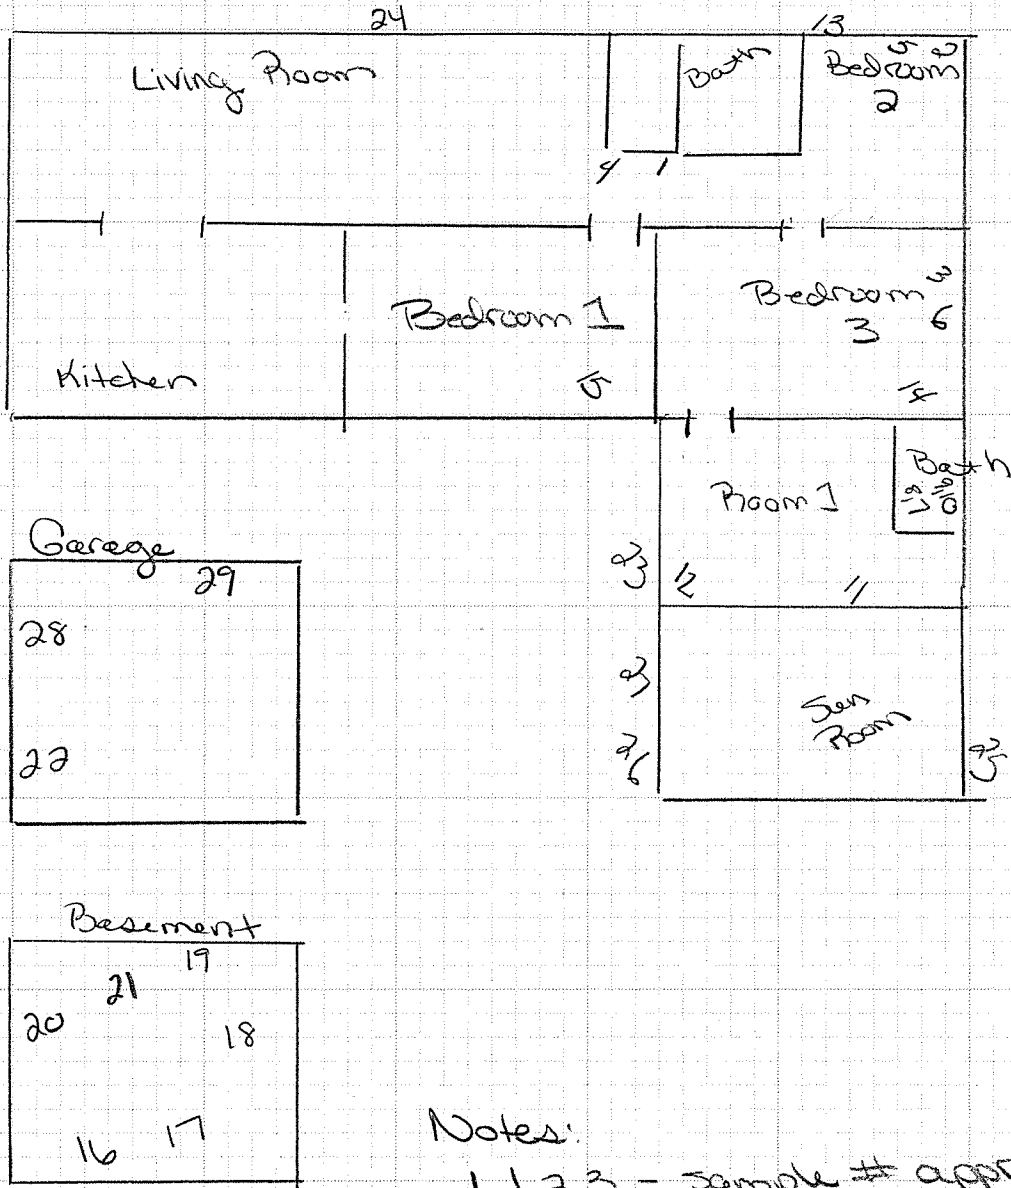
JOB 1 Elizabeth Street  
SHEET NO. 1 OF \_\_\_\_\_  
CALCULATED BY JR DATE \_\_\_\_\_  
CHECKED BY \_\_\_\_\_ DATE \_\_\_\_\_  
SCALE NTS

Notes:  
1, 1, 2, 3 - sample # approx. location  
2. Representative Sampling  
3. Vermiculite insulation is REM

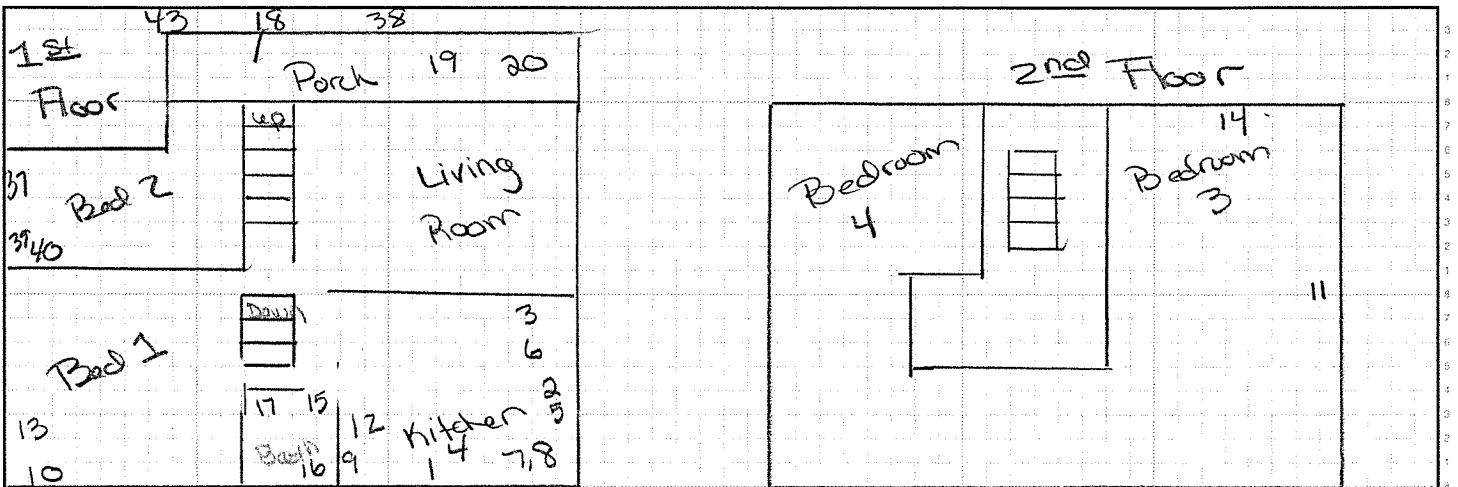
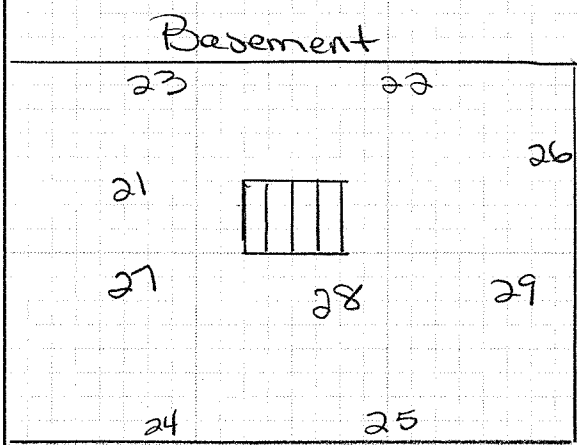
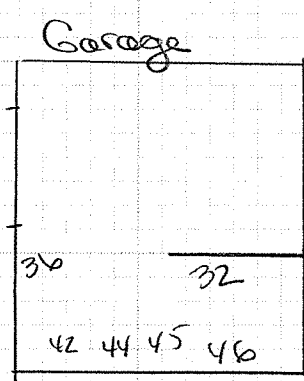
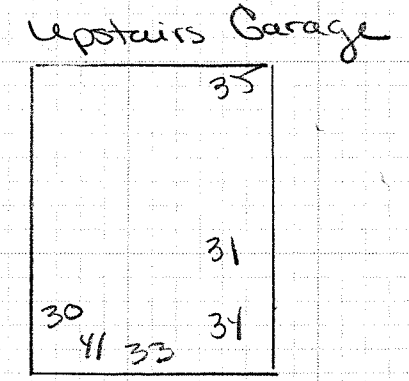
JOB 7 Maryland Street  
 SHEET NO. 1 OF 1  
 CALCULATED BY JR DATE \_\_\_\_\_  
 CHECKED BY \_\_\_\_\_ DATE \_\_\_\_\_  
 SCALE NTS

Notes:  
 1. 1, 2, 3 - Sample # approx. location  
 2. Representative Sampling  
 3. Chimney Flashing is assumed AEM

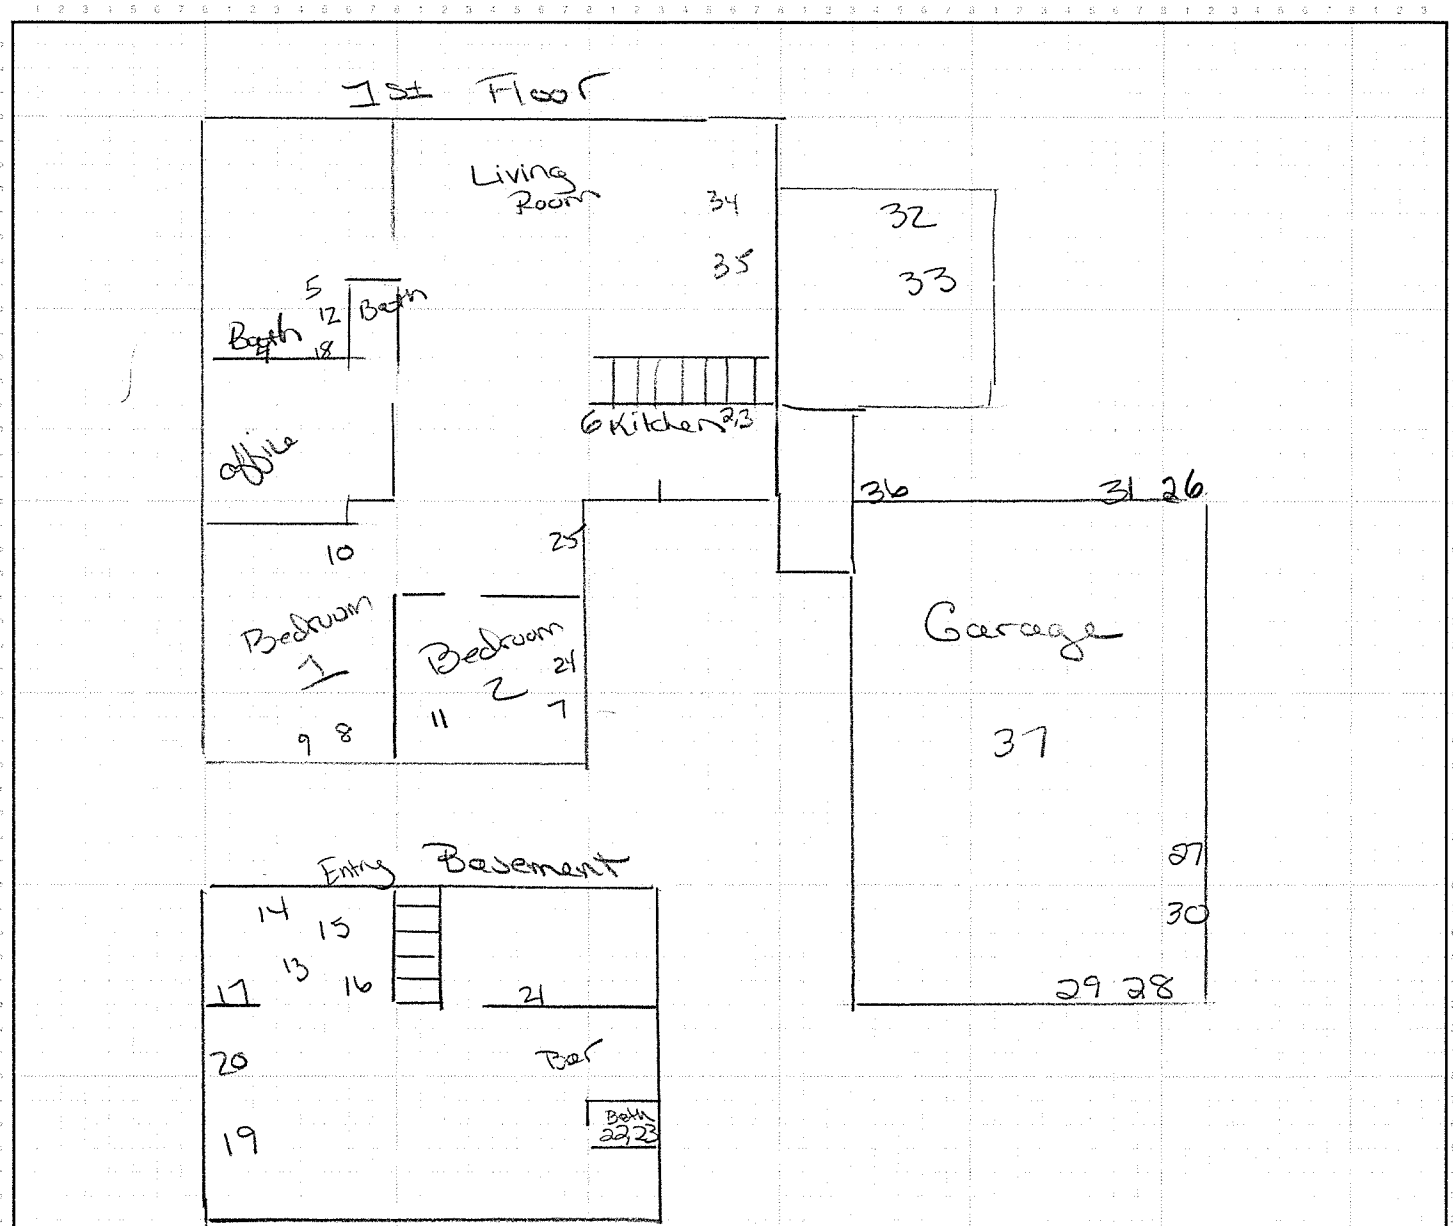
JOB 54 North Henry Court - 503150368  
 SHEET NO. 1 OF \_\_\_\_\_  
 CALCULATED BY AK DATE 4/3/15  
 CHECKED BY \_\_\_\_\_ DATE \_\_\_\_\_  
 SCALE NTS

- Notes:
- 1, 2, 3 - Sample # approx. location
  2. Representative Sampling
  3. Vermiculite insulation is ACM
  4. Transite siding is ACM
