RE: Phase I Environmental Site Assessments, Miscellaneous Property Group, Burlington
International Airport, South Burlington, Vermont

PHASE I ENVIRONMENTAL SITE ASSESSMENT REPORT

**Miscellaneous Property Group
Various Properties
South Burlington, Vermont 05403**

KAS Proj. #509110230

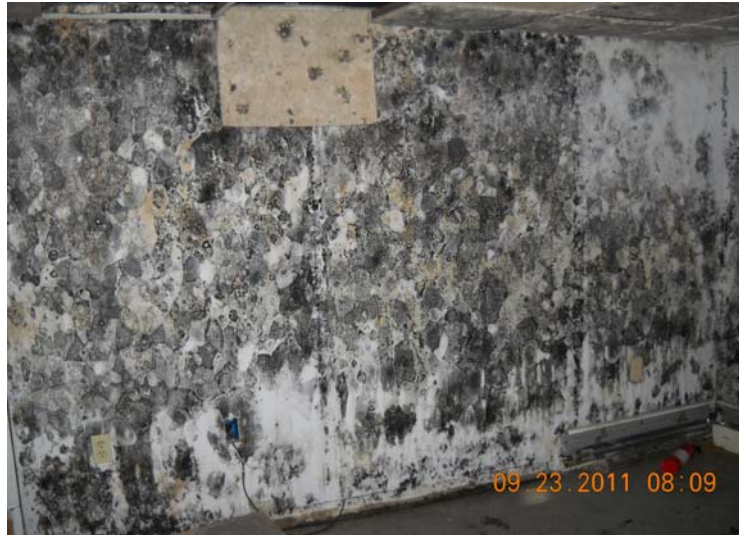
Photograph ID: 02

Comments:
View of basement wall
Extensive mold growth

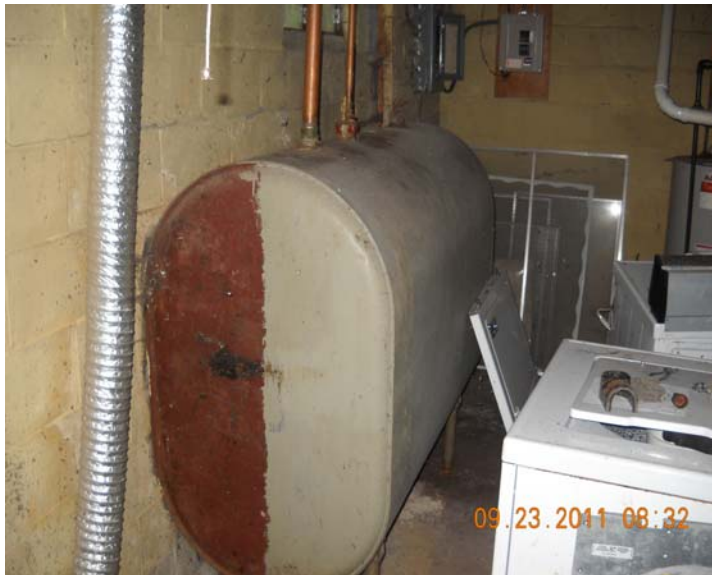
Photograph ID: 06

Approximately 275-gallon heating oil ASTs were identified in 1131, 1171 and 1257 Airport Drive during the site reconnaissance. The ASTs were in good condition with only de minimis staining observed below.

Comments:
View of AST in the basement

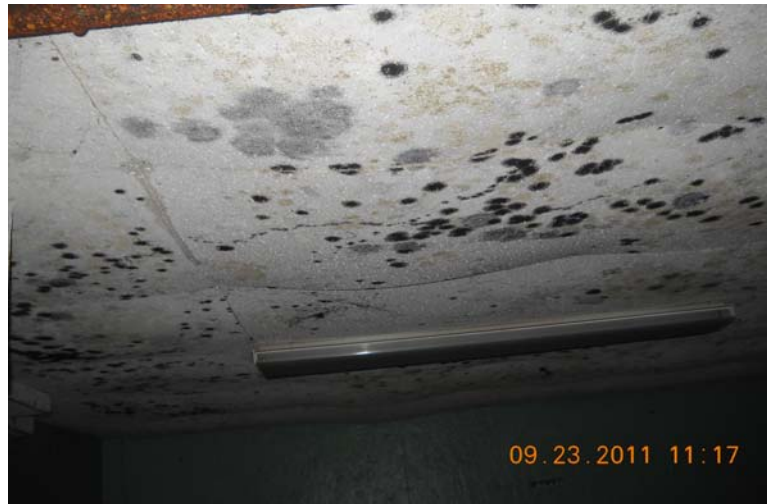
Photograph ID: 08

Comments:
View of back apartment ceiling
Significant mold growth

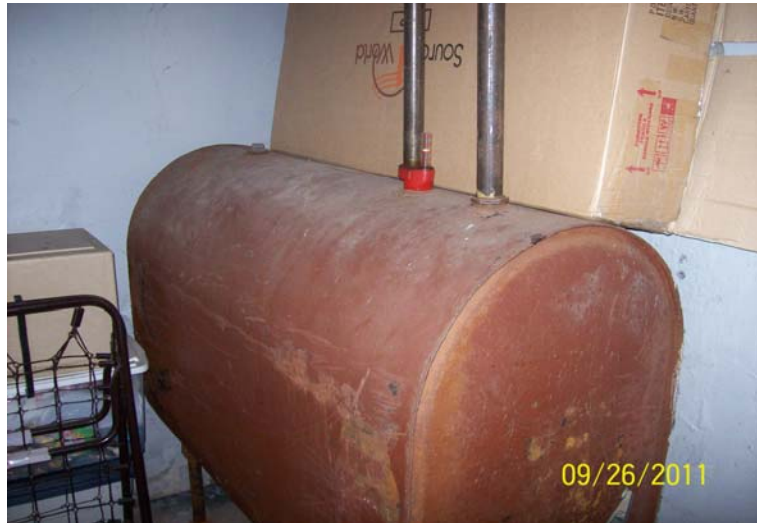
Photograph ID: 010

Comments:
View of AST in the basement

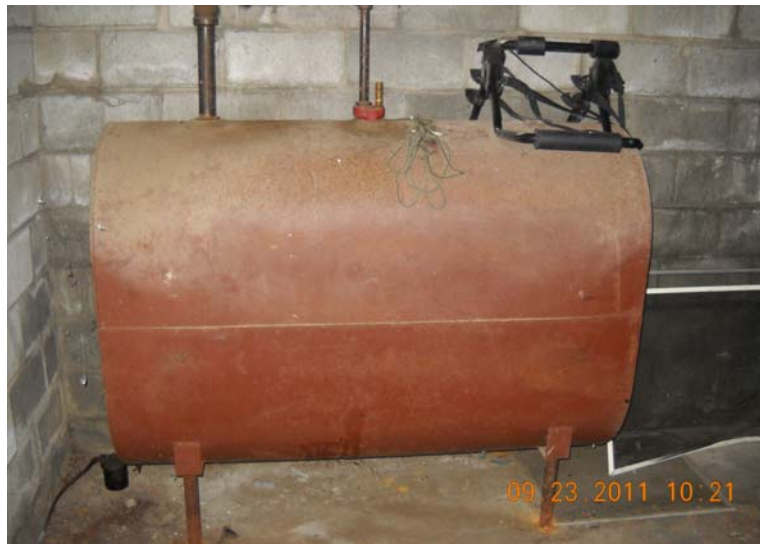
Photograph ID: 016

Comments:
View of AST in the basement
