RE: Phase I Environmental Site Assessments, AIP 74, Burlington International  
Airport, South Burlington, Vermont

**PHASE I  
ENVIRONMENTAL SITE  
ASSESSMENT REPORT**

**AIP #74  
Various Properties  
South Burlington, Vermont 05403**

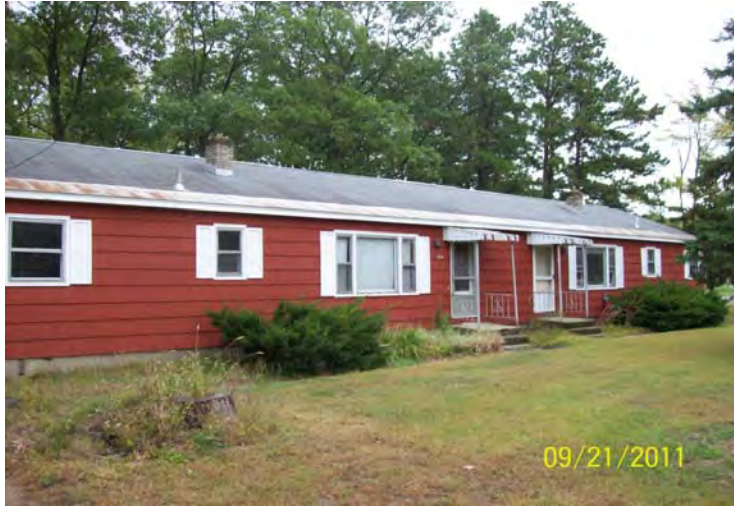
Photograph ID: 01  
21-Sep-11  
Location:  
200-202 Airport Parkway  
Direction:  
East  
Comments:  
Front of duplex family housing  
structure

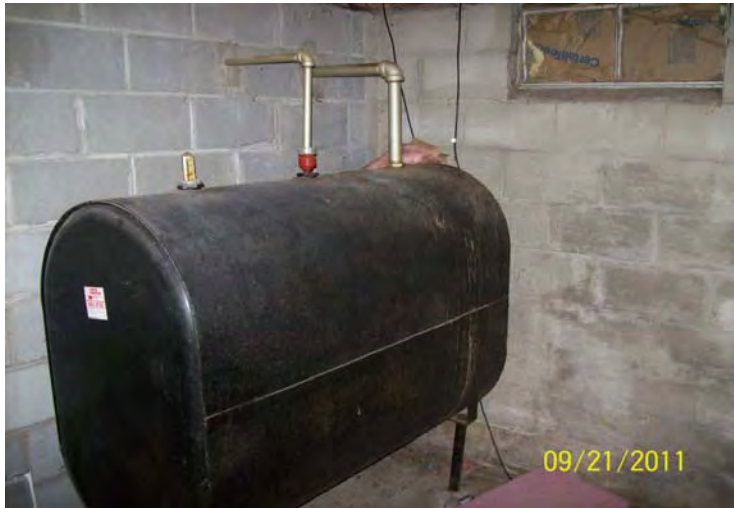
Photograph ID: 02  
21-Sep-11  
Location:  
200 Airport Parkway  
Direction:  
North  
Comments:  
View of AST in basement space

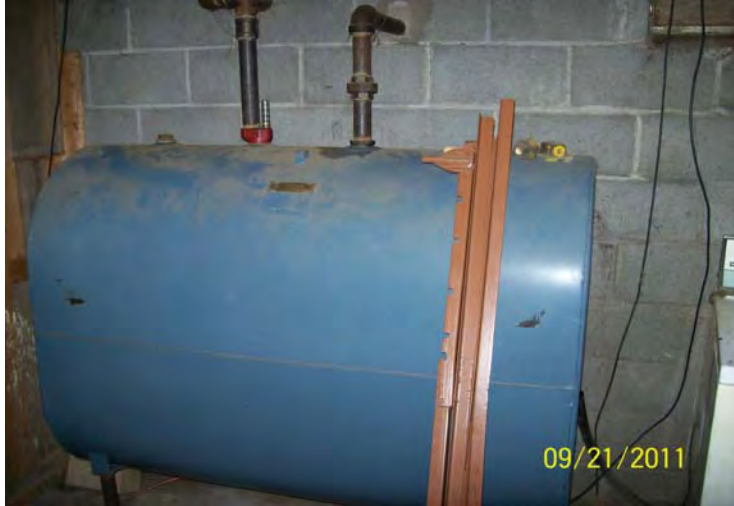
Photograph ID: 03  
21-Sep-11  
Location:  
202 Airport Parkway  
Direction:  
South  
Comments:  
View of AST in basement space

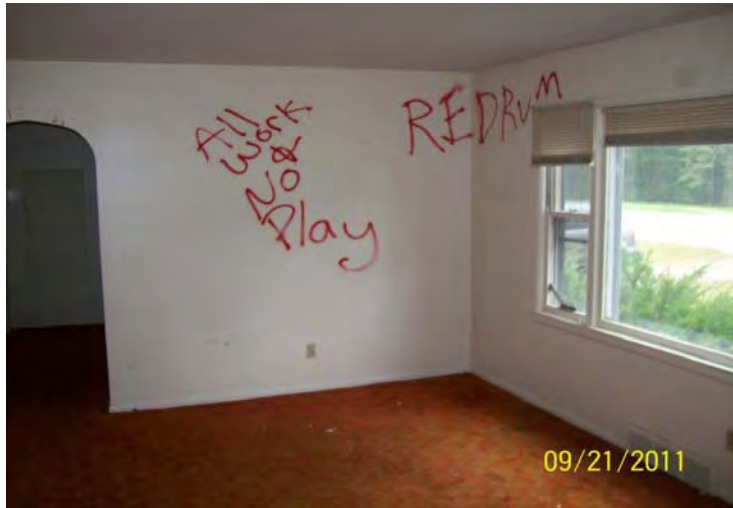
Photograph ID: 04  
21-Sep-11  
Location:  
200-202 Airport Parkway  
Direction:  
South  
Comments:  
View of the interior living space

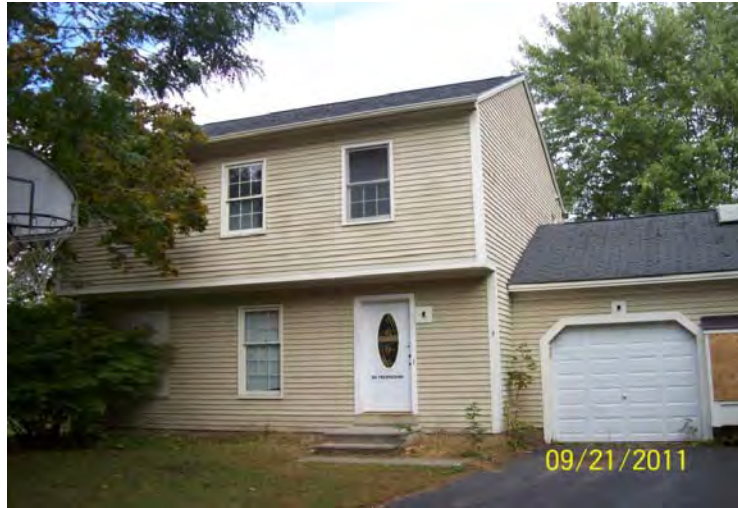
Photograph ID: 05  
21-Sep-11  
Location:  
4 Picard Circle  
Direction:  
Northeast  
Comments:  
Front of single family housing structure

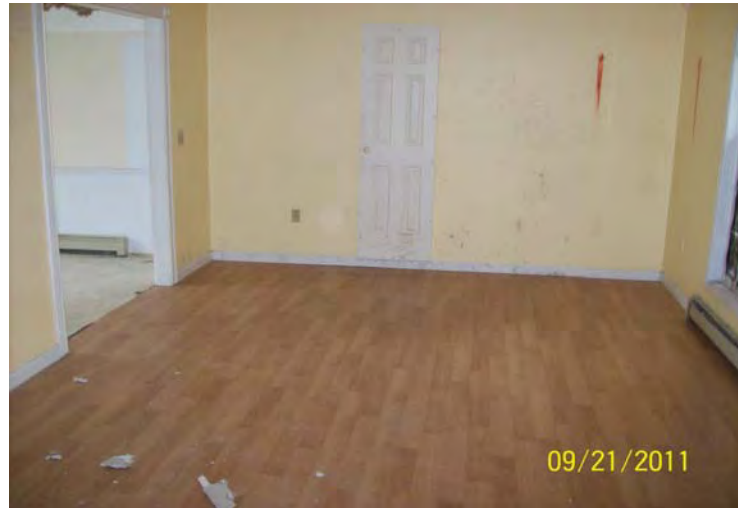
Photograph ID: 06  
21-Sep-11  
Location:  
4 Picard Circle  
Direction:  
Northeast  
Comments:  
View of the interior living space

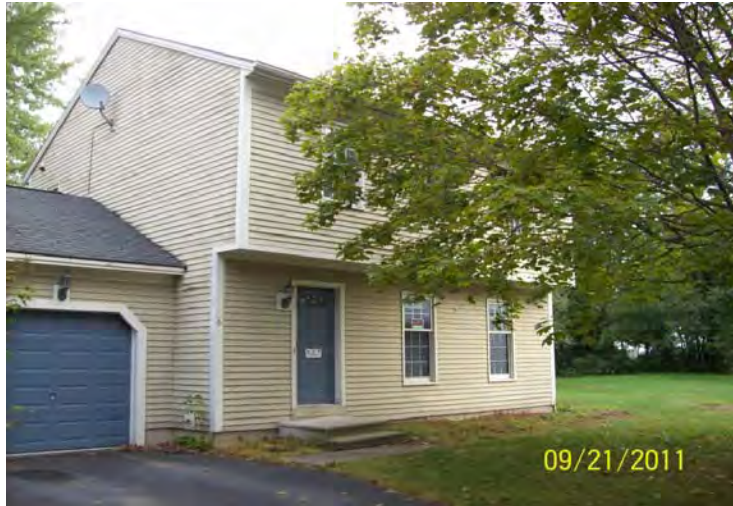
Photograph ID: 07  
21-Sep-11  
Location:  
6 Picard Circle  
Direction:  
Northeast  
Comments:  
Front of single family housing structure

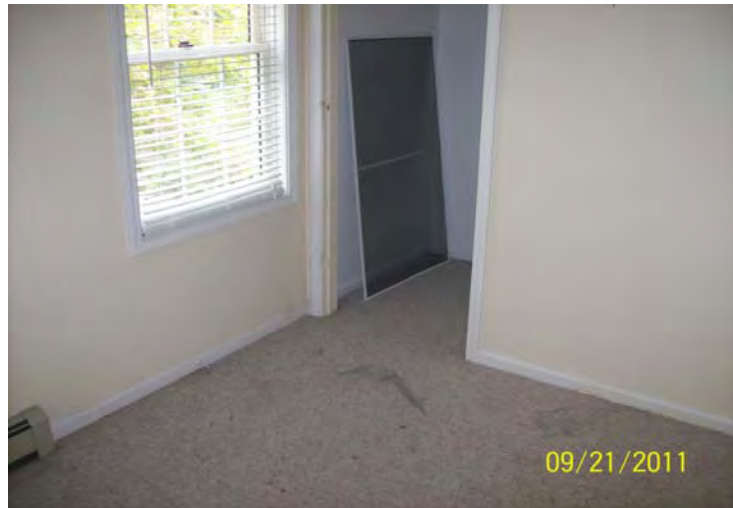
Photograph ID: 08  
21-Sep-11  
Location:  
6 Picard Circle  
Direction:  
Northeast  
Comments:  
View of the interior living space

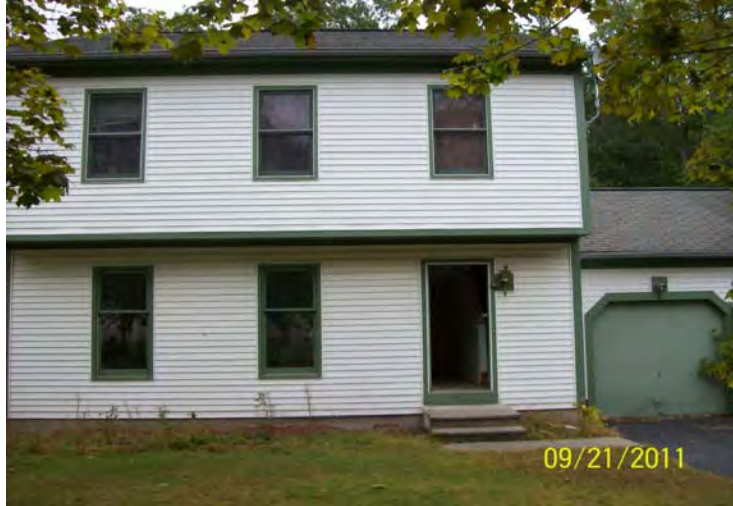
Photograph ID: 09  
21-Sep-11  
Location:  
8 Picard Circle  
Direction:  
East  
Comments:  
Front of single family housing structure

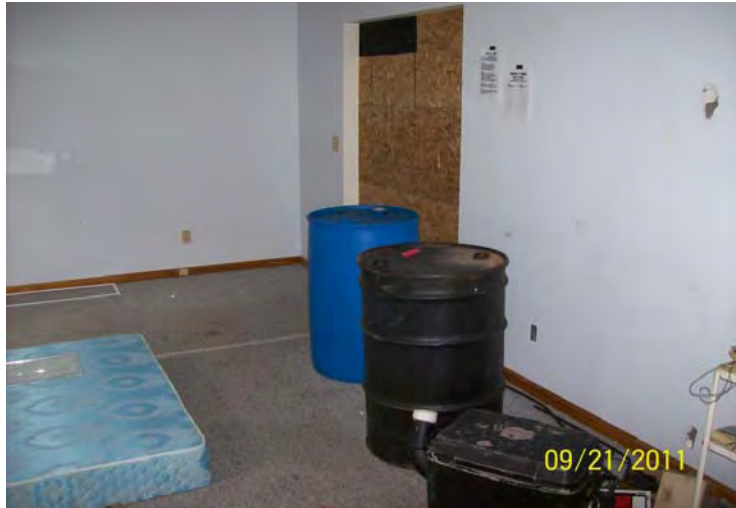
Photograph ID: 010  
21-Sep-11  
Location:  
8 Picard Circle  
Direction:  
North  
Comments:  
View of interior living space and two empty drums

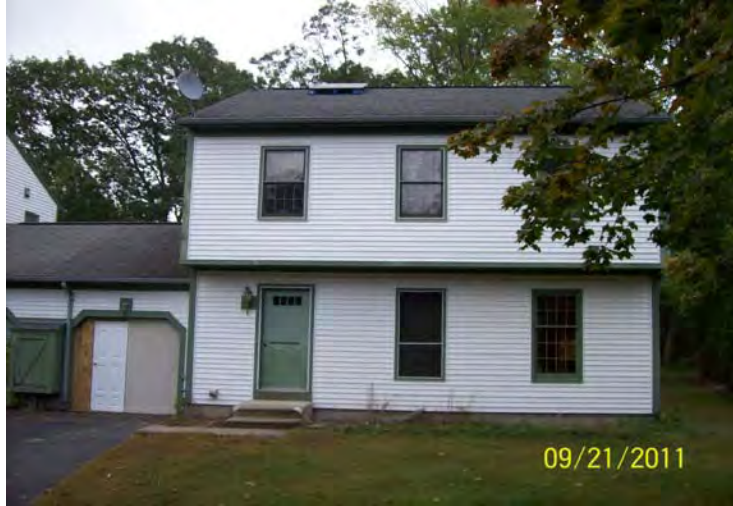
Photograph ID: 011  
21-Sep-11  
Location:  
10 Picard Circle  
Direction:  
East  
Comments:  
Front of single family housing structure

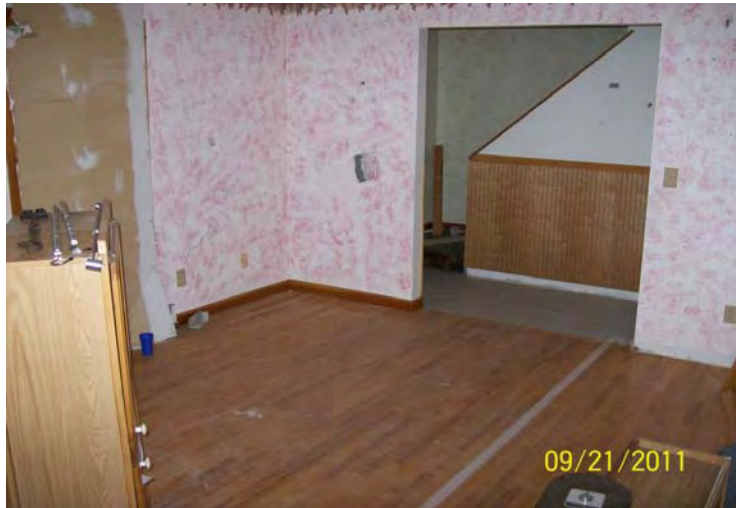
Photograph ID: 012  
21-Sep-11  
Location:  
10 Picard Circle  
Direction:  
East  
Comments:  
View of interior living space

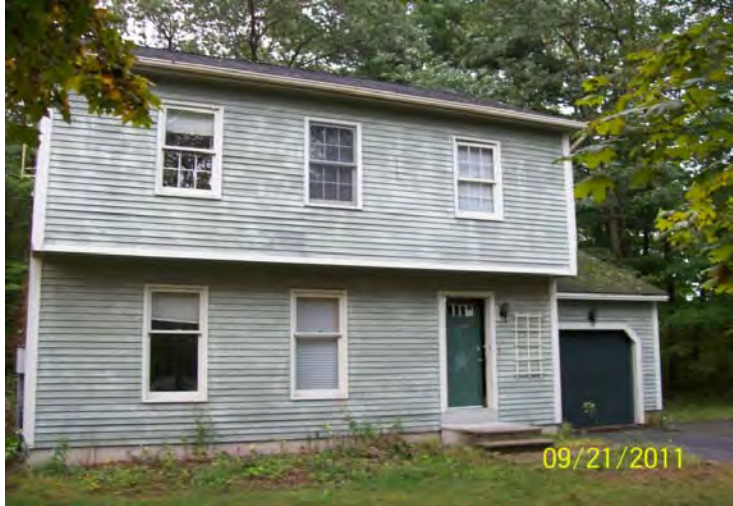
Photograph ID: 013  
21-Sep-11  
Location:  
12 Picard Circle  
Direction:  
Southeast  
Comments:  
Front of single family housing structure

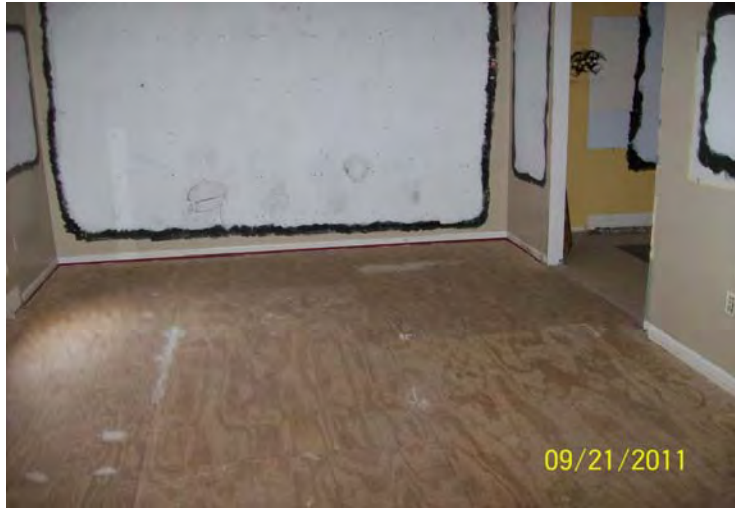
Photograph ID: 014  
21-Sep-11  
Location:  
12 Picard Circle  
Direction:  
Southeast  
Comments:  
View of interior living space

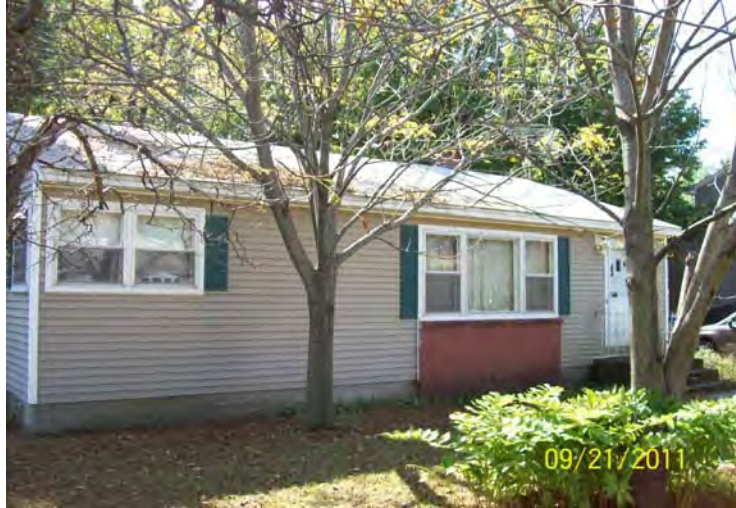
Photograph ID: 015  
21-Sep-11  
Location:  
61 Dumont Street  
Direction:  
South  
Comments:  
Front of single family housing structure

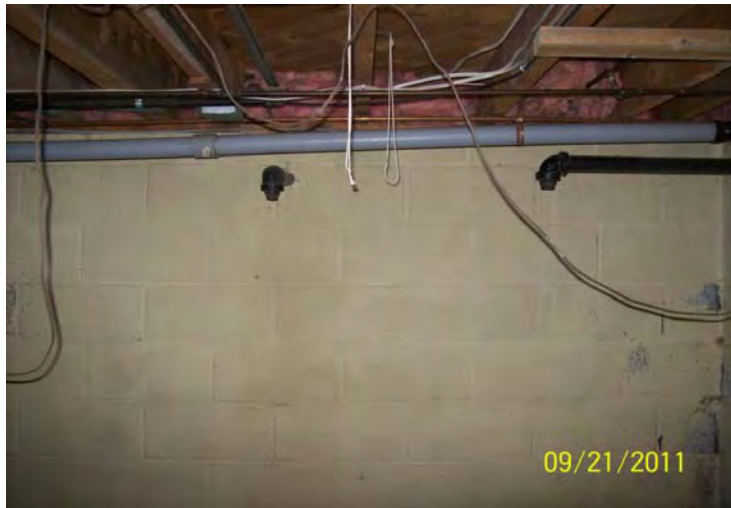
Photograph ID: 016  
21-Sep-11  
Location:  
61 Dumont Street  
Direction:  
South  
Comments:  
View of former AST fill pipes in basement space

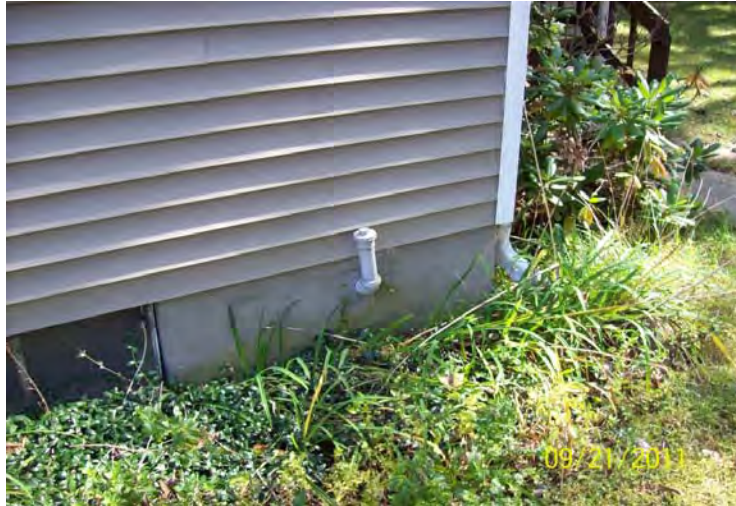
Photograph ID: 017  
21-Sep-11  
Location:  
61 Dumont Street  
Direction:  
East  
Comments:  
View of AST fill pipe on the exterior of the house

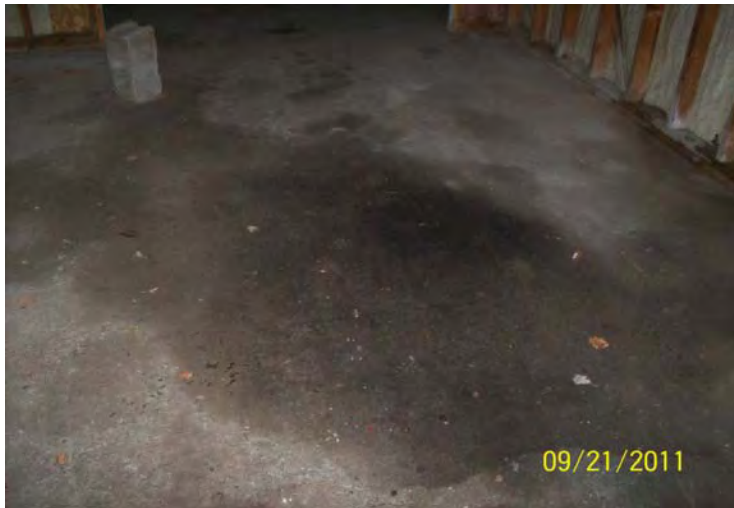
The staining noted under the above ground storage tank inside the basement of the 400 White Street property and on the concrete floor within the garage at 61 Dumont Avenue is considered a de minimis condition as defined by ASTM and as outlined in Sections 9.0 and 10.0.

Photograph ID: 018  
21-Sep-11  
Location:  
61 Dumont Street  
Direction:  
South  
Comments:  
View of some staining on the concrete floor in the garage

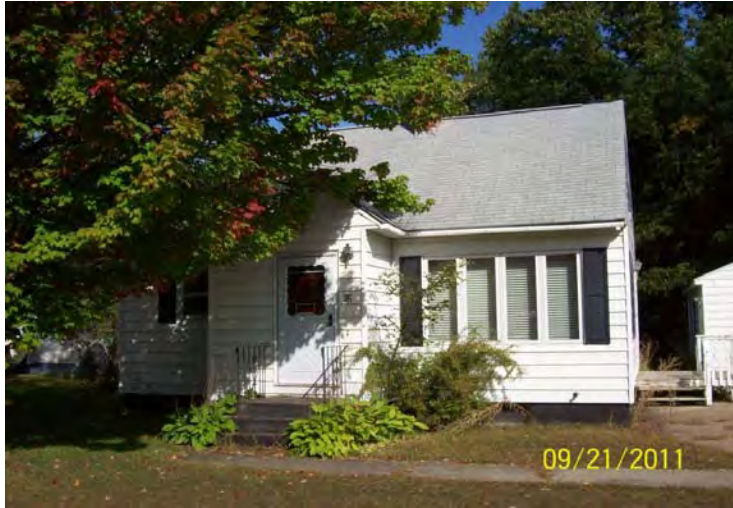
Photograph ID: 019  
21-Sep-11  
Location:  
76 Dumont Street  
Direction:  
North  
Comments:  
Front of single family housing structure

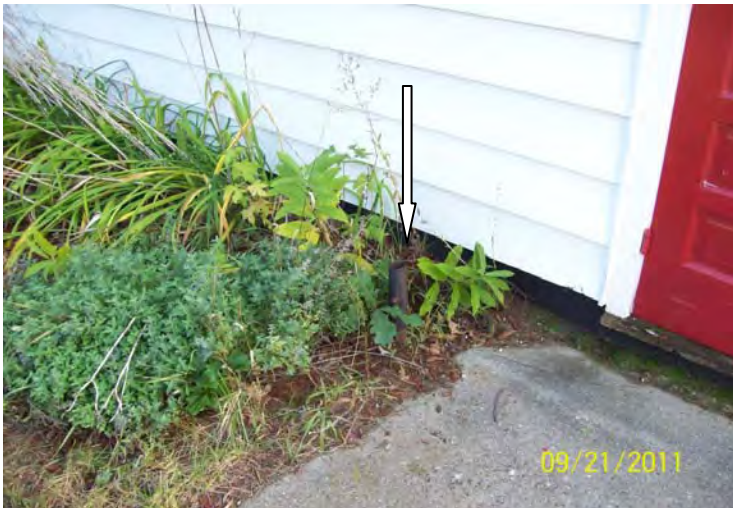
An additional investigation is deemed necessary to ascertain the presence or absence of a REC at the 76 Dumont Avenue property and the 4, 6, 8, 10, and 12 Picard Circle properties. The steel pipe protruding from the ground near the garage at the 76 Dumont Avenue property needs additional investigation to determine if this pipe is associated with an underground storage tank. An interview with the former owner of an adjacent property of land to the Picard Circle properties indicated a dump used to be present near the properties. Additional investigation is needed to ascertain whether or not this is a REC.

No evidence of storage tanks were noted on the exterior of the subject properties. A hollow steel pipe was observed protruding out of the ground near the garage on the 76 Dumont Street property. The purpose of the pipe was not clear from the site reconnaissance.

Photograph ID: 020  
21-Sep-11  
Location:  
76 Dumont Street  
Direction:  
Northeast  
Comments:  
View of steel pipe protruding from the ground near the garage

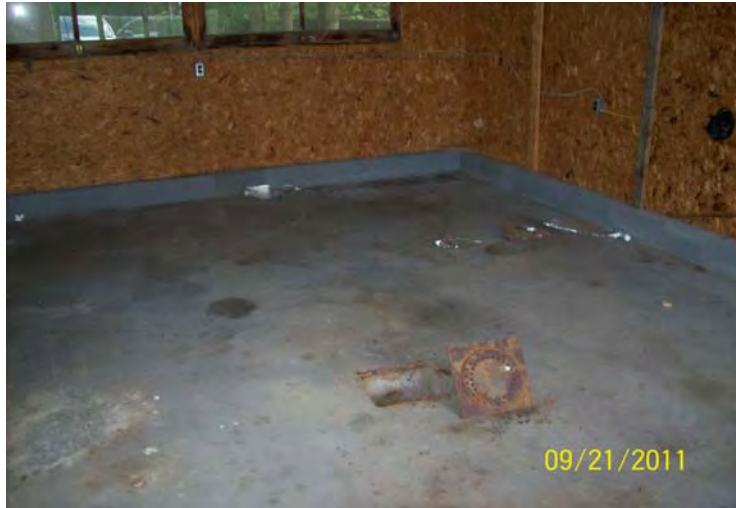
Photograph ID: 021  
21-Sep-11  
Location:  
61 Dumont Street  
Direction:  
East  
Comments:  
View of the floor drain inside the garage

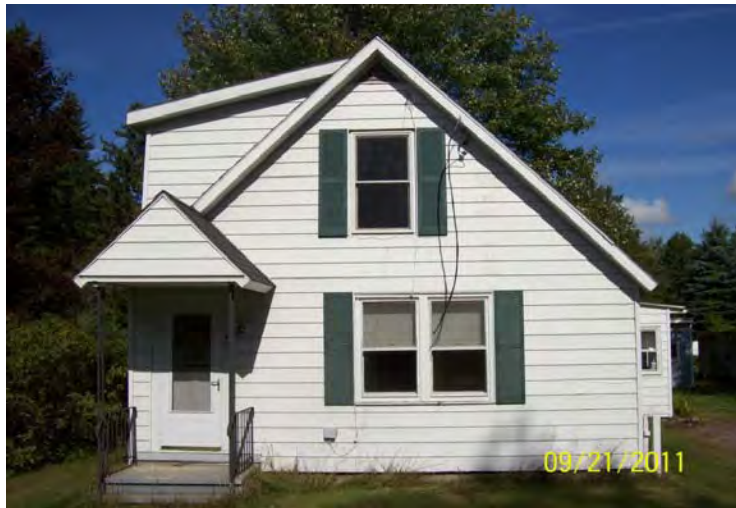
Photograph ID: 022  
21-Sep-11  
Location:  
400 White Street  
Direction:  
North  
Comments:  
Front of single family housing structure

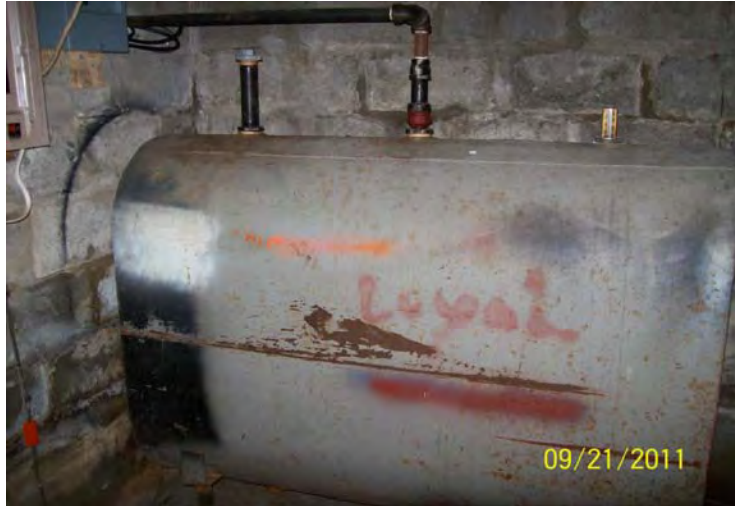
Photograph ID: 023  
21-Sep-11  
Location:  
400 White Street  
Direction:  
West  
Comments:  
View of the AST in the basement  
space

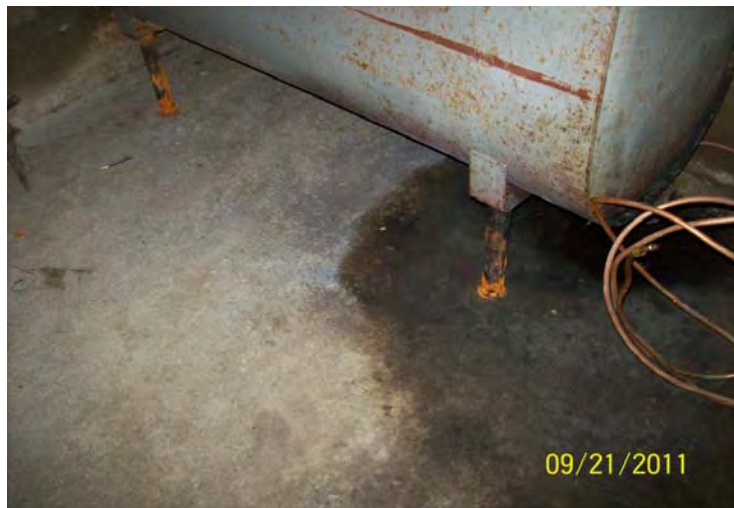
Photograph ID: 024  
21-Sep-11  
Location:  
400 White Street  
Direction:  
South  
Comments:  
View of the staining under the  
AST

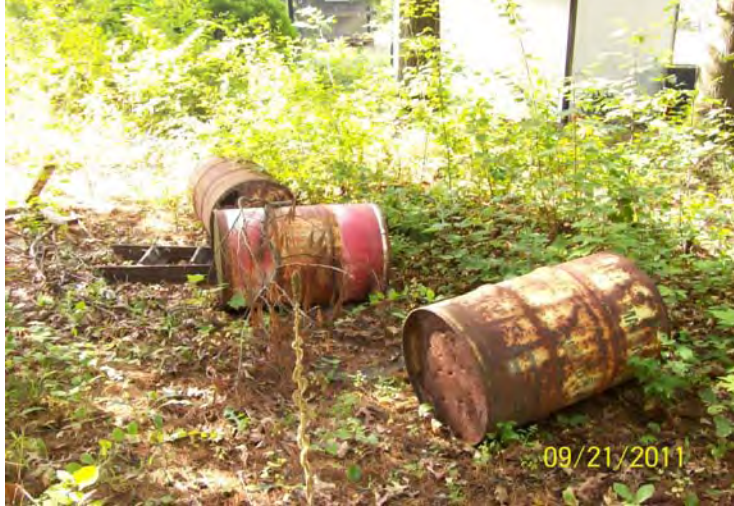
One recognized environmental condition (REC) was identified during this assessment: the presence of three corroded and damaged drums immediately outside a garage that appeared to be used for automobile repair at the 400 White Street property. Although the drums were empty and no staining was noted around the drums visual observations of the garage near the drums suggested automobiles were repaired inside the garage. A mark was observed on the concrete floor inside the garage. The markings were representative of an above ground lift. Additionally, the garage was constructed with a high ceiling immediately above the marks on the concrete. The presence of the empty and damaged drums outside this area suggests that there was a potential release of hazardous materials at one time. The drums were unlabeled and thus the previous contents of the drums could not be determined.

Photograph ID: 025  
21-Sep-11  
Location:  
400 White Street  
Direction:  
West  
Comments:  
View of the three drums noted on  
the exterior of the property

KAS, Inc. is pleased to present the attached Phase I Environmental Site Assessment (ESA) report for the AIP 74 above referenced properties. The ESA was conducted in compliance with ASTM E-1527-05. One recognized environmental condition (REC) was identified during this assessment: the presence of three corroded and damaged drums immediately outside a garage that appeared to be used for automobile repair at the 400 White Street property. KAS recommends that these drums should be removed and the soils should be screened to determine if a release to the subsurface has occurred.

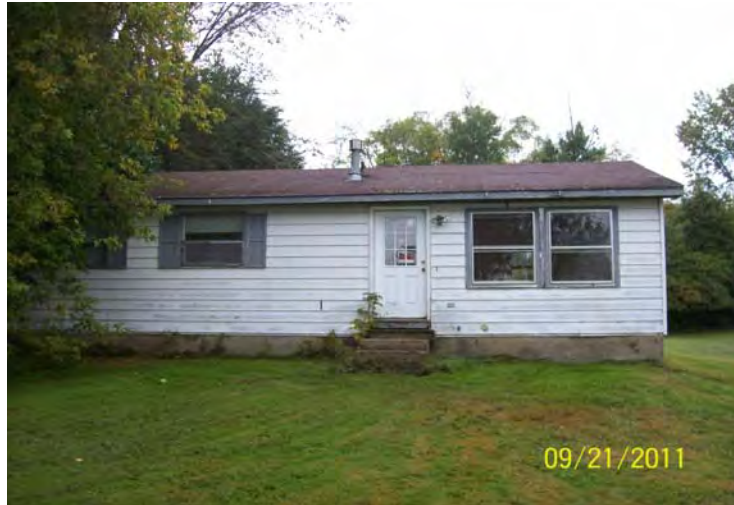
Photograph ID: 026  
21-Sep-11  
Location:  
7 Shamrock Road  
Direction:  
West  
Comments:  
Front of single family housing  
structure

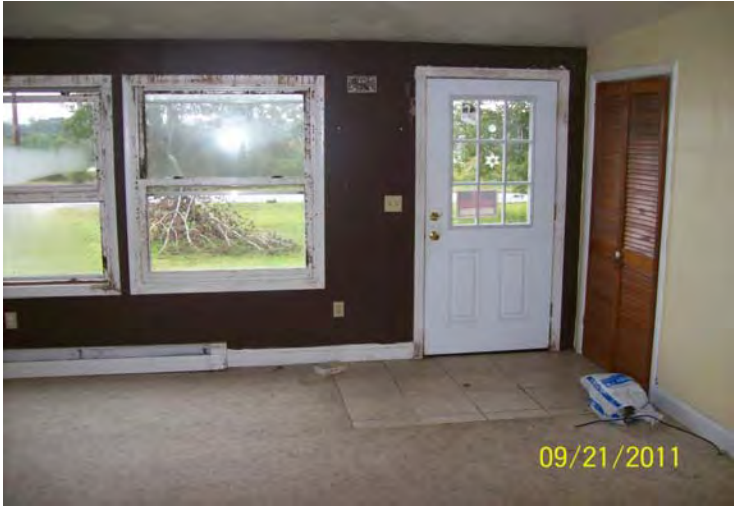
Photograph ID: 027
21-Sep-11
Location: 7 Shamrock Road
Direction: East
Comments: View of the interior living space
