RE: Phase I Environmental Site Assessments, AIP 84, Burlington International Airport,
South Burlington, Vermont

PHASE I ENVIRONMENTAL SITE ASSESSMENT REPORT

**AIP #84
Various Properties
South Burlington, Vermont 05403**

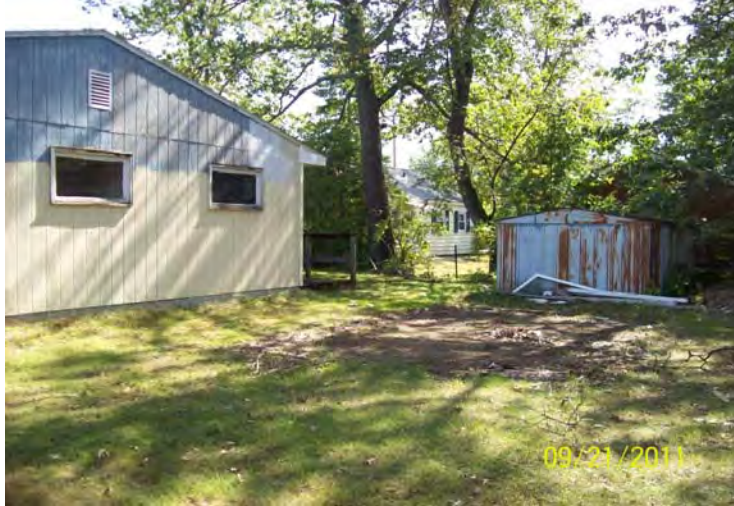
Photograph ID: 03
21-Sep-11
Location:
1185 Airport Drive
Direction:
East
Comments:
View of backyard with area of former shed

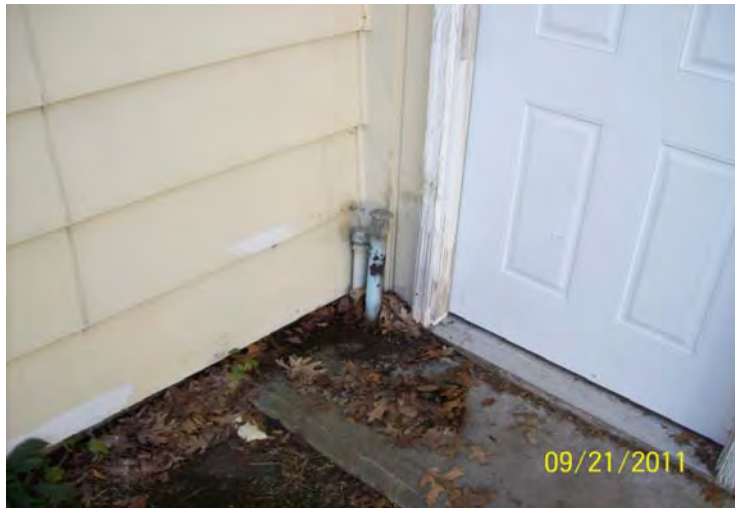
Photograph ID: 04
21-Sep-11
Location:
1185 Airport Drive
Direction:
Southwest
Comments:
View of the UST fill and vent pipe

KAS, Inc. is pleased to present the attached Phase I Environmental Site Assessment (ESA) report for the AIP 84 above referenced properties. The ESA was conducted in compliance with ASTM E-1527-05. One recognized environmental condition (REC) was identified during this assessment: the presence of an underground storage tank (UST) at the 1185 Airport Drive property. KAS recommends this UST be removed from the ground and a UST closure assessment be conducted in accordance with state regulations.

One recognized environmental condition (REC) was identified during this assessment: the presence of an underground storage tank at the 1185 Airport Drive property.

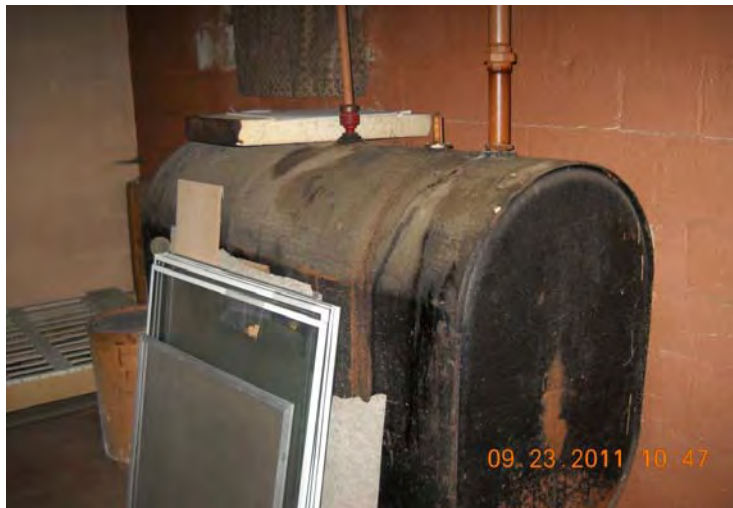
Photograph ID: 06
23-Sep-11
Location:
3 Patrick Street
Direction:
South
Comments:
View of the AST in the basement

Evidence of two of the other properties previously using fuel oil to heat the structures was noted during the site reconnaissance. These properties are 3 Patrick Street and 38 N. Henry Court. The remaining properties did not supply visual evidence suggesting oil was stored on these properties. Typical of Chittenden County urban areas, natural gas was installed in the 1960's and many of the tanks and oil burners were removed or left in place. There was no evidence of fuel oil contamination encountered during the reconnaissance. There were no indications of foundation wall penetrations by oil lines which could be indicative of USTs outside the buildings.

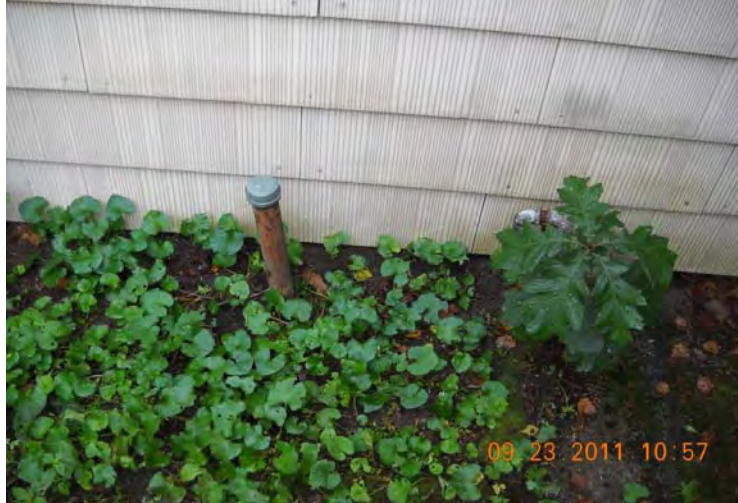
Photograph ID: 07
23-Sep-11
Location:
3 Patrick Street
Direction:
East
Comments:
View of the AST fill pipe noted
outside

An additional investigation is deemed necessary to ascertain the presence or absence of a REC at the 3 Patrick Street property. The steel pipe protruding from the ground near the house needs additional investigation to determine if this pipe is connected to the aboveground storage tank (AST) in the basement or if it is associated with an underground storage tank.

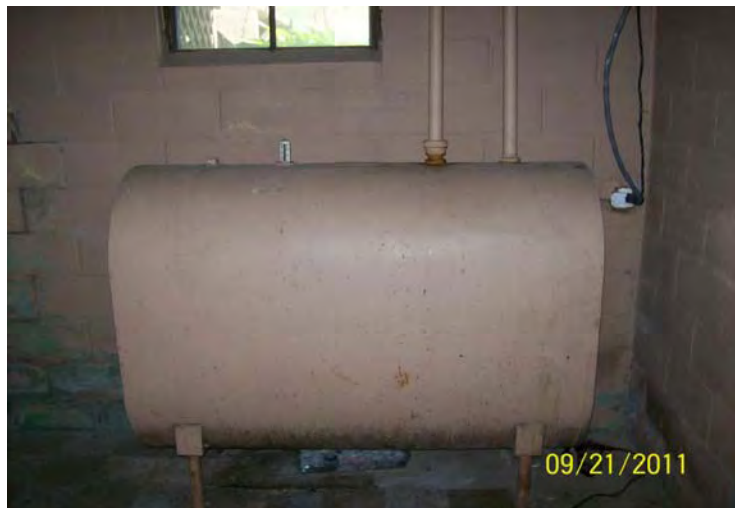
Photograph ID: 012
21-Sep-11
Location:
38 N. Henry Court
Direction:
South
Comments:
View of the AST in the basement

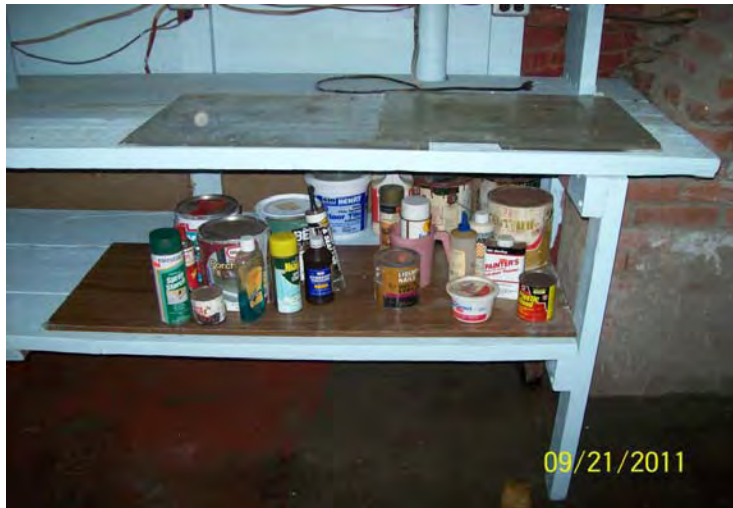
Photograph ID: 016
21-Sep-11
Location:
2 Ledoux Terrace
Direction:
South
Comments:
View of the de minimis quantities of paints, adhesives, and cleaners in basement
