**PHASE II ENVIRONMENTAL
ASSESSMENT REPORT**

**Burlington International Airport House Removals
AIP 74**

South Burlington, Vermont 05403

February 9, 2012

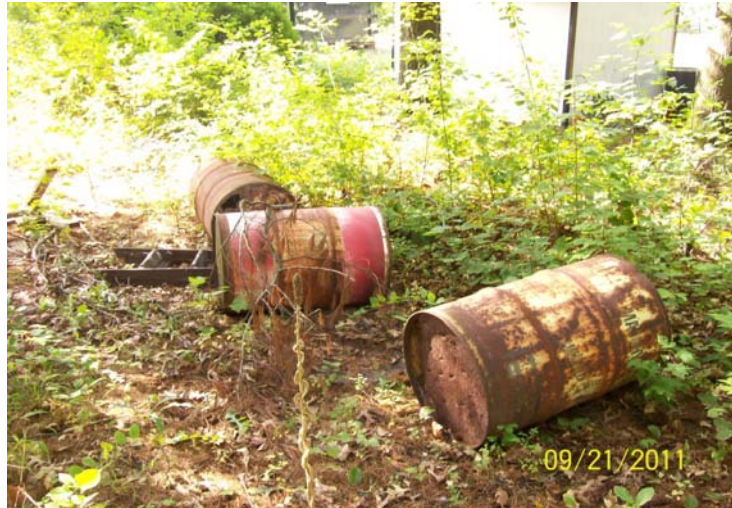
Photograph ID: 01

Location:
400 White Street Drum area

This is the area where the soil boring were done. No evidence of petroleum or chemical contamination was found.

On December 2, 2011 a KAS scientist advanced several soil borings on the 400 White Street property. The borings were advanced to address the REC that was identified during the Phase I ESA (the presence of three corroded and damaged drums immediately outside a garage that appeared to be used for automobile repair). The approximate locations of the borings are indicated on the Site Sketch in Appendix E. A photograph of the drum area is included in Appendix B.

The borings were advanced by KAS using a hand auger. The borings were advanced to a depth of approximately ½ to 4 feet below grade. A properly calibrated photoionization device (PID) was used to screen the soil samples collected in the field at approximately every 6" interval for volatile organic compounds (VOCs). VOCs above background were measured with the PID in all the soil samples collected from the soil borings on December 2, 2011 except at one location. The area in the vicinity of the drums is located beneath several pine trees and pine needles were observed to cover the ground surface. The elevated PID readings in the soil samples were attributed to the degradation of the pine needles. No odor was noted in the soil samples collected from the soil borings and it did not appear that the ground was contaminated with petroleum or chemicals. Groundwater was

As part of the Phase II ESA, the three 55-gallon drums were removed by EP&S under bill of lading on December 19, 2011, and properly disposed of at Burnett's Scrap Metal in Hinesburg. A bill of lading for the drum removal is included in Appendix C.

- No household hazardous wastes were identified or removed from houses within AIP 74.
- Soils at 400 White Street near the location of a former automotive repair facility were screened and did not appear to be contaminated. No further Phase II action is required. Three 55-gallon drums were removed from the site and disposed of properly.

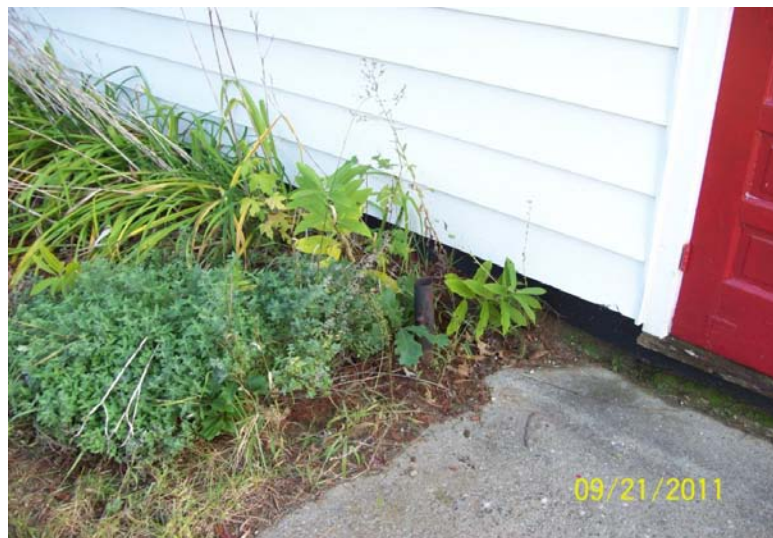
Photograph ID: 02

Location:
76 Dumont Avenue

Comments:
View of pipe of unknown purpose adjacent to the garage.

Investigative activities took place at the 76 Dumont Avenue property on December 2, 2011. The suspect pipe noted to be protruding from the ground near the garage was located. The pipe was observed to be 1.5-inch diameter and consisted of steel. The pipe was excavated using a backhoe to determine if an UST is present in this location (see Site Sketch in Appendix E). Hand digging was conducted to remove soils closer to the garage foundation. Photographs of the work site are included in Appendix B.

- A pipe sticking out of the ground at 76 Dumont Avenue was found to be a former fence post and was not related to a UST or an AST. No further Phase II action is required.

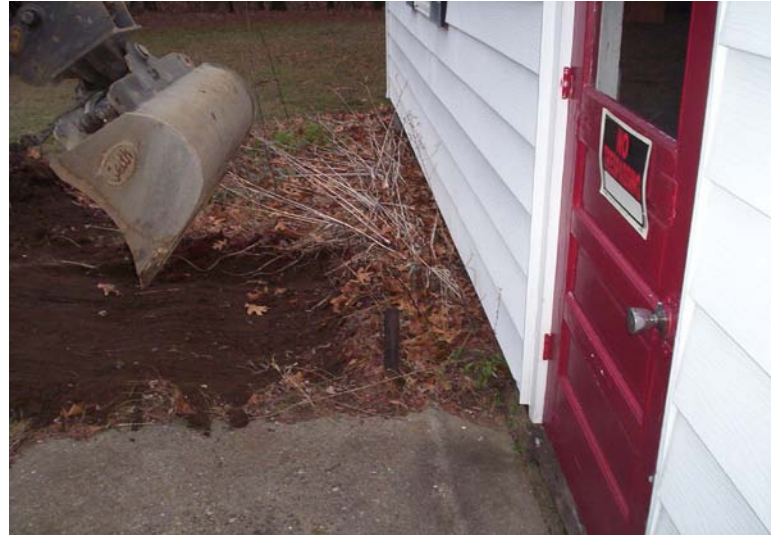
Photograph ID: 03

Location:
76 Dumont Ave.

Comments:
excavation of pipe next to garage

The excavator traced the pipe to its end. The pipe was found to be crimped off at approximately 2-3 feet below grade. The pipe was observed to be encased in concrete. The excavator dug down to approximately 4-5 feet below grade to confirm the pipe was not previously connected to a UST. No UST was discovered and no signs of contamination were observed. It was determined that this pipe was likely an old fence post. No contamination was noted during the excavation and no indications that this pipe was connected to an underground storage tank (UST) were found.

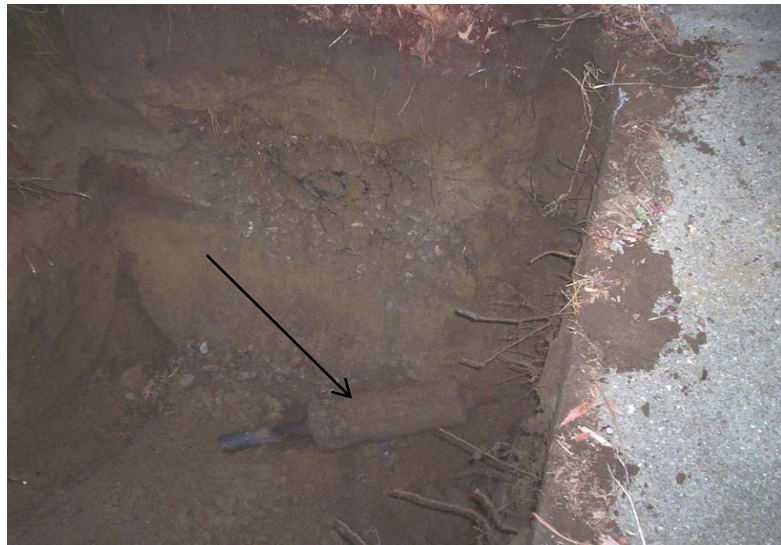
Photograph ID: 04

Location:
76 Dumont Avenue

Comments:
pipe encased in concrete in
excavation is not associated
with a tank

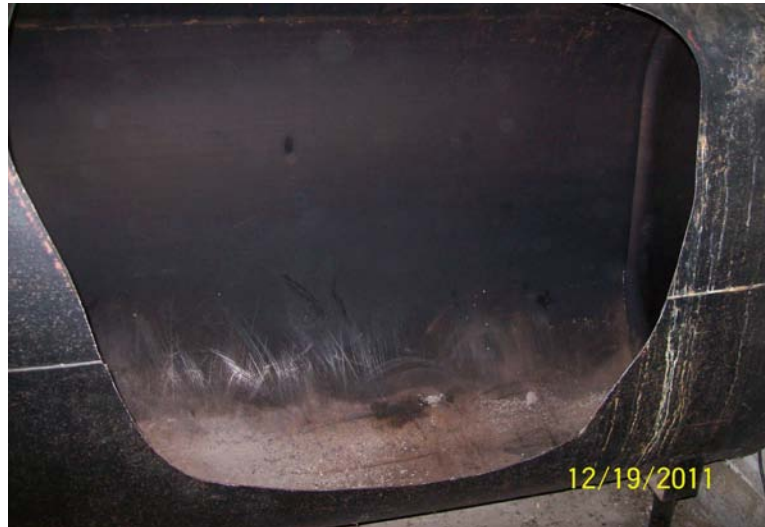
Photograph ID: 05

Location:
200 Airport Parkway

Comments:
View of cleaned decommissioned
AST in basement

KAS coordinated, observed and documented the decommissioning of three ASTs formerly used for storage of #2 fuel oil for home heating purposes. Two of the ASTs were in the basement of 200-202 Airport Parkway¹ and the third AST was in the basement at 400 White Street. EP&S performed the decommissioning work which included cutting and cleaning the ASTs, manually draining the oil supply and return lines to the furnace (when possible and not inaccessible beneath basement floors or walls), removing the fill and vent piping, and placing the cleaning wastes (including sludge, oil, water, and personnel protective equipment) into containers for shipping to a licensed disposal facility. EP&S also performed documentation including obtaining the appropriate EPA waste generator identification numbers for each location, completing and mailing the waste manifest paperwork, and compiling the documentation and providing it to KAS.

- Three former fuel oil ASTs were successfully decommissioned at 200-202 Airport Parkway and at 400 White Street. Waste materials were properly managed and removed from the properties. The cleaned ASTs

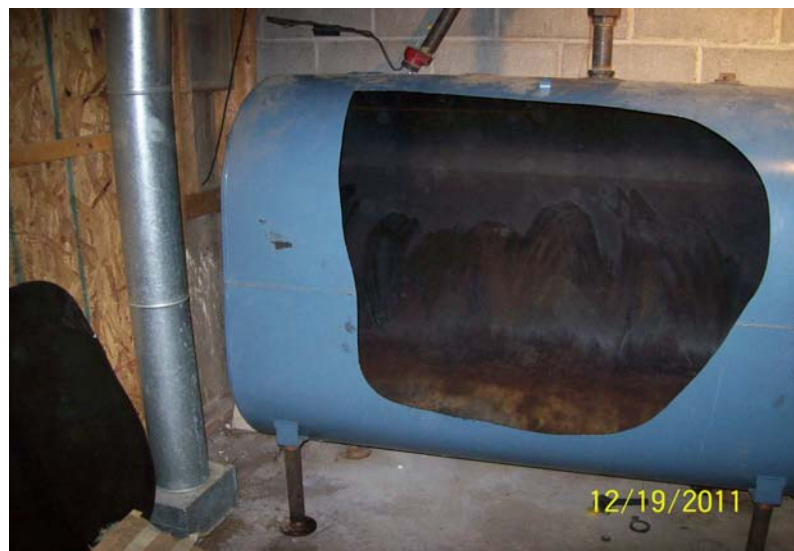
Photograph ID: 06

Location:
202 Airport Parkway

Comments:
View of cleaned decommissioned
AST in basement

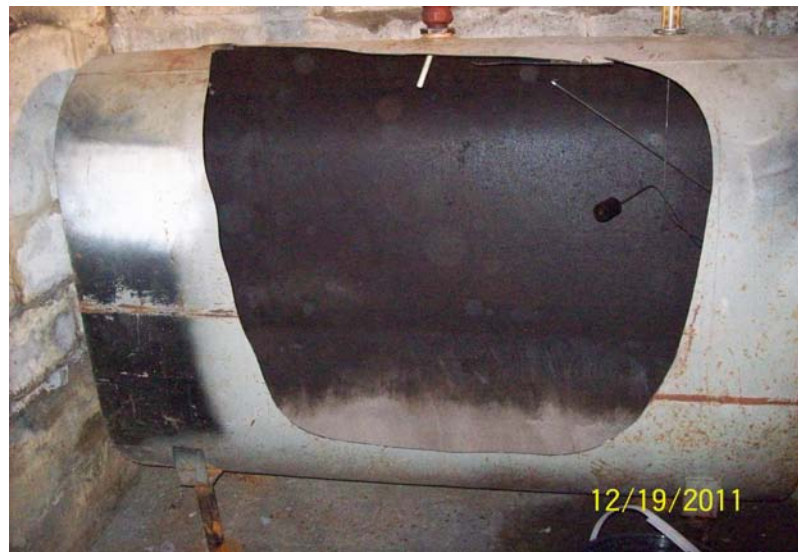
Photograph ID: 07

Location:
400 White Street

Comments:
View of cleaned decommissioned
AST in basement

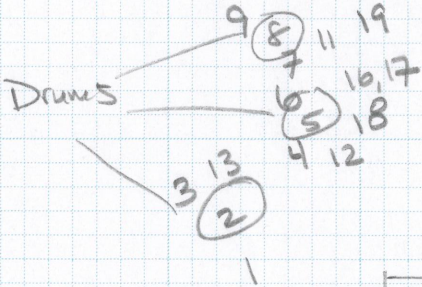
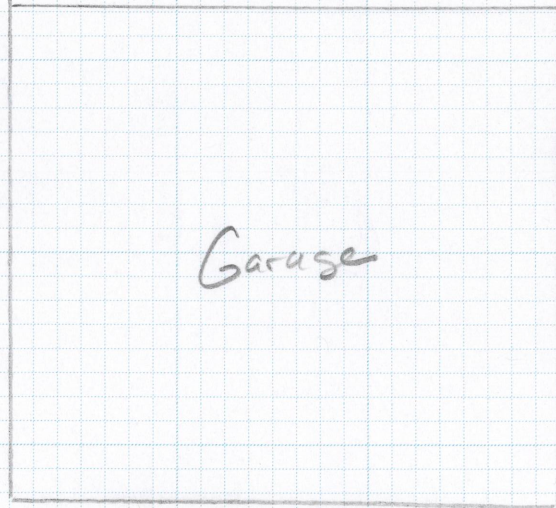
Site Sketch
 Phase II ESA - Sample locations

JOB 400 White Street
 SHEET NO. 1 OF 1
 CALCULATED BY _____ DATE _____
 CHECKED BY _____ DATE _____
 SCALE Not to Scale

Sample #	PID	Soil Type	Depth
1	5.6	Silty Sand	0-6"
2	11.6		
3	7.0		
4	25.3		
5	8.7		
6	12.7		
7	0.0		
8	24.8		
9	1.2		
10	5.7		
11	17.7		
12	14.0		
13	1.3		
14	1.1		
15	36.2		
16	0.5		
17	5.6		
18	1.7		
19	1.9

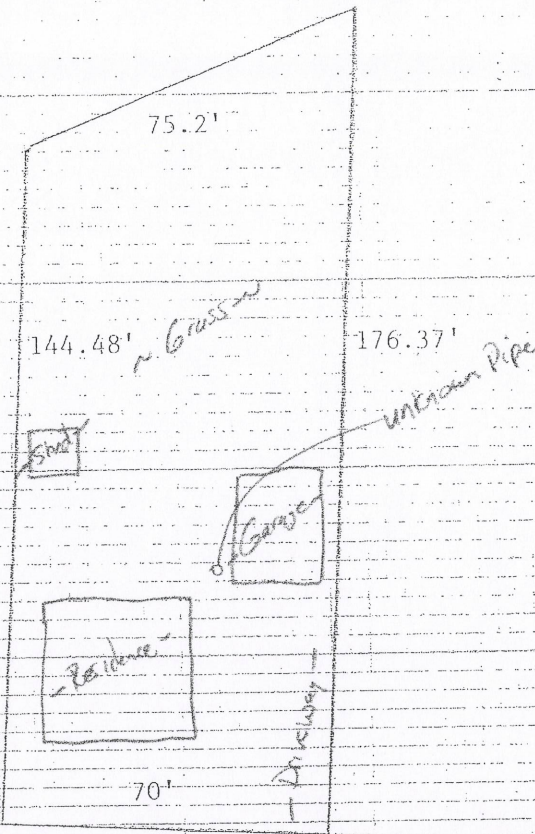
SITE PLAN

76 DUMONT AVE
obtained from Nain D'Ordy
Appraisal Services

KAS conducted an investigation into the purpose of a pipe observed sticking out of the ground at 76 Dumont Avenue, to determine whether it was related to a tank or other environmentally significant feature. KAS performed a site visit on November 29, 2011 to premark the property for DigSafe notification. DigSafe # 2011490386 was assigned to the project.
