**BURLINGTON INTERNATIONAL AIRPORT  
BOARD OF AIRPORT COMMISSIONERS**

SUBJECT: Lease Agreement with Department of the Air Force, Vermont Air National Guard

**EXHIBIT D—ENVIRONMENTAL BASELINE SURVEY/ENVIRONMENTAL CONDITION OF  
PROPERTY REPORT**

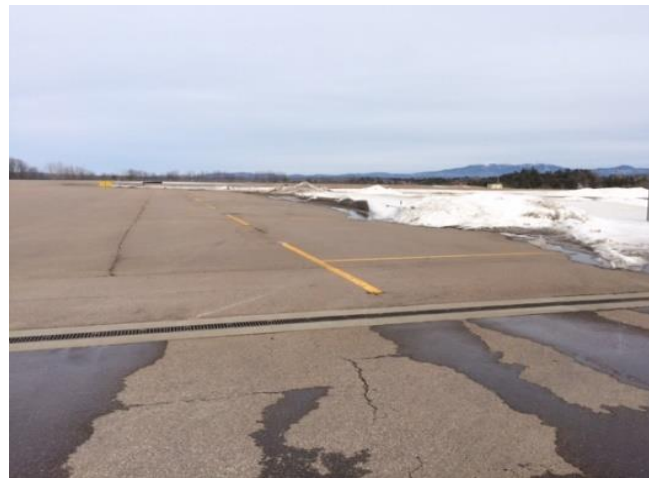
**Photograph 3-1. View of the Apron looking east**

**Apron**—This concrete apron was built in 2009 for the purpose of parking commercial aircraft. It currently is used as parking for commercial aircraft. The southeastern side of the apron is shown in Photograph 3-1.

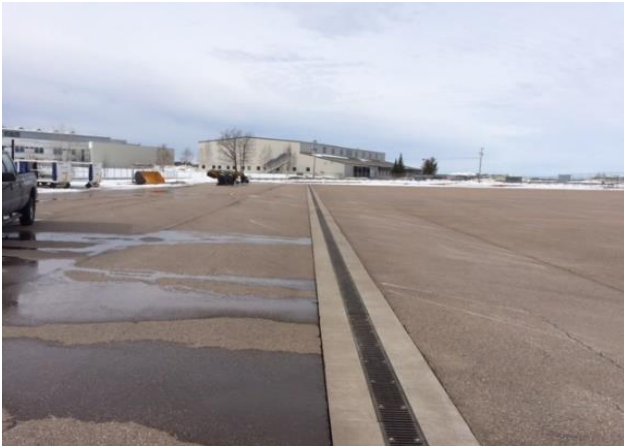
**Photograph 3-2. View of southwestern side of Apron**

**Apron**—This concrete apron was built in 2009 for the purpose of parking commercial aircraft. It currently is used as parking for commercial aircraft. The southwestern side of the apron is shown in Photograph 3-2.

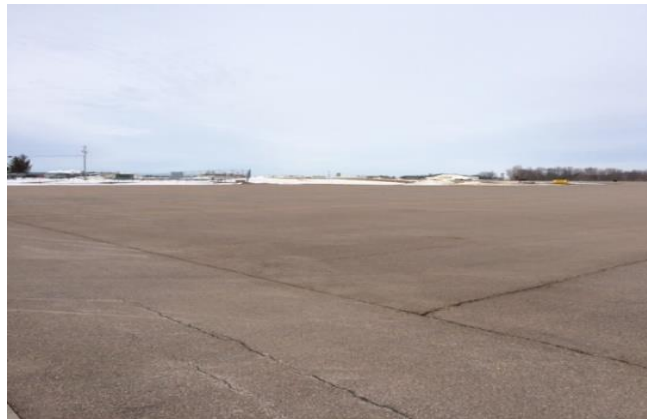
**Photograph 3-3. View of the Apron looking northeast**

**Apron**—This concrete apron was built in 2009 for the purpose of parking commercial aircraft. It currently is used as a parking apron for commercial aircraft. The view of the apron looking northeast is shown in Photograph 3-3.

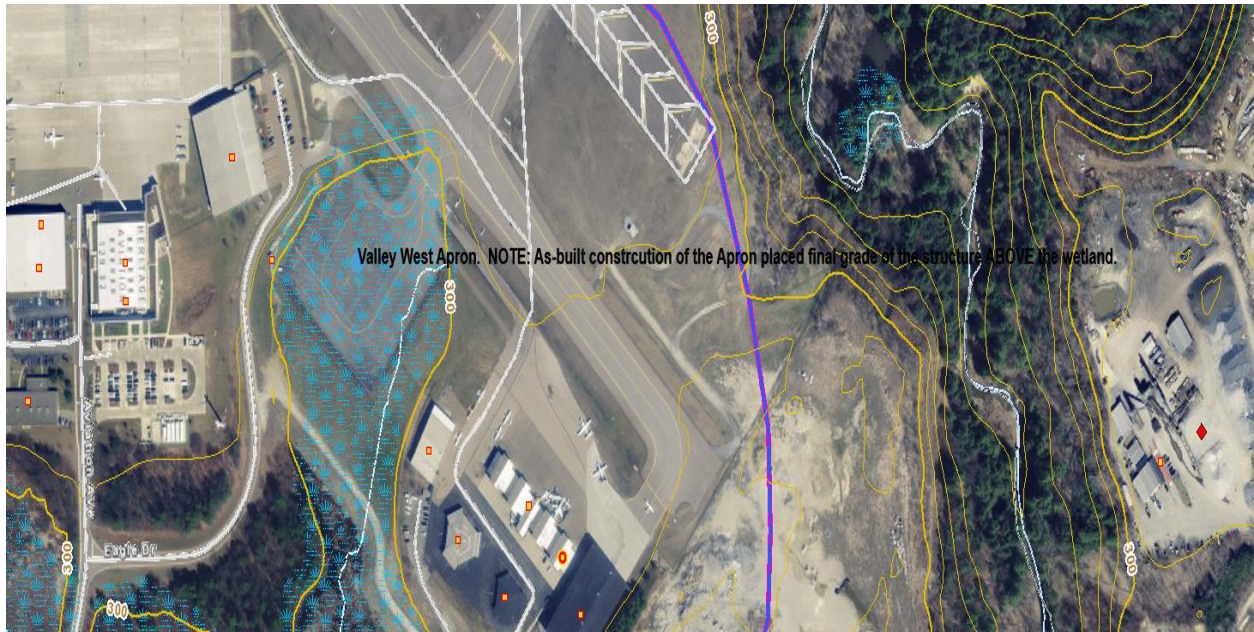
According to the data found in the Vermont Center for Geographic Information database, Class 2 designated wetlands formerly existed on the property prior to the construction of the Valley West Apron. It should be noted the map in Figure 3-5b reflects the extent of the former wetlands in addition to the remaining adjacent wetlands. These wetlands were identified in the April 2005 Environmental Assessment.

**Figure 3-5b. Wetlands Map**  
**(Does not reflect Apron final elevation grade of 325 feet, which is**  
**no longer considered a wetland on or directly adjacent to, the Apron)**  
**Valley West Apron, South Burlington Vermont**
