ASBESTOS INSPECTION REPORT
1089, 1233, 1383 Airport Drive, 69 Dumont Street, 238
Kirby Road, 5, 8, 11, 15/17 Ledoux Terrace, 13, 17
Maryland Street, 420 White Street
South Burlington, VT 05403
AIP 94

April 29, 2015

Stantec, Inc.
55 Green Mountain Drive
South Burlington, VT 05403

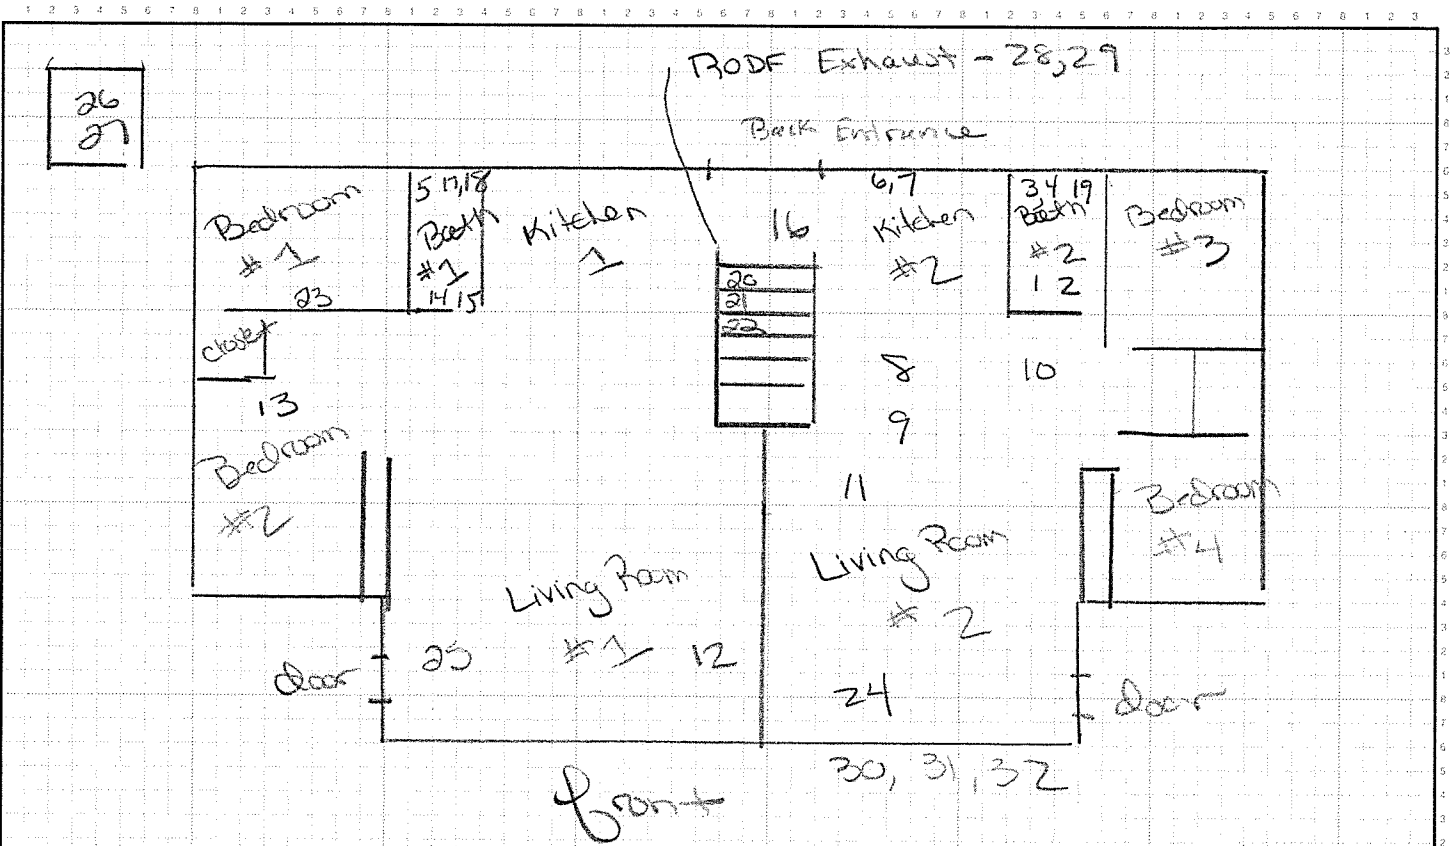
JOB 13 Maryland Street - 503/50369
 SHEET NO. _____ OF _____
 CALCULATED BY JP DATE 4/3/15
 CHECKED BY _____ DATE _____
 SCALE NTS

1. 1, 2, 3 - Sample # approximate location
2. Drawing Representative
3. No QCM
